**Support to the development of joint research actions
between national programmes on advanced nuclear materials**

FP7-Fission-2013
Combination of Collaborative project (CP) and Coordination and Support Actions (CSA)

D.5.42

***Report for mech./microstr. character. of environ.
assisted degrade. effects of steels in lead alloys
and assess. of environm. degrad. effects on perf.
of struct. and funct. comp. of MYRRHA ADS &
LFR***

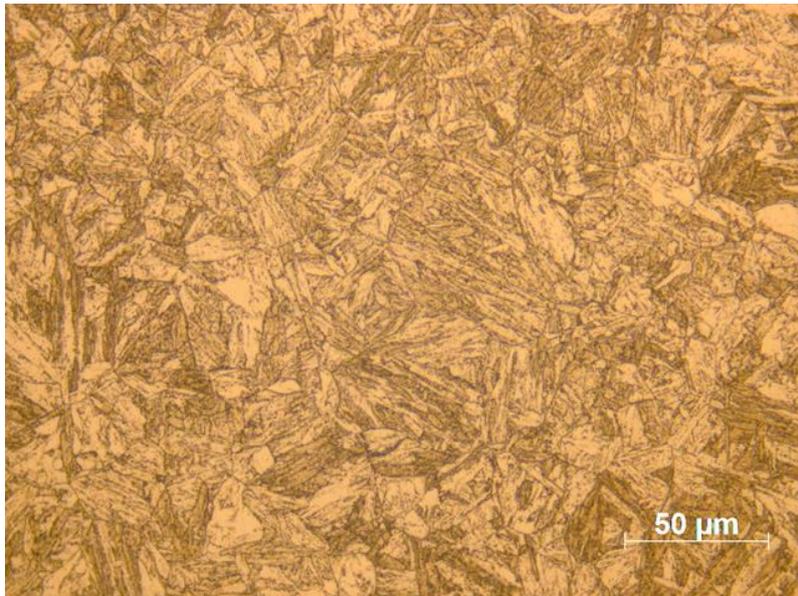
Figure 3.1: Typical microstructure of tested T91 material [33]

Material was provided as 15 mm thick plates. The final microstructure is shown in Figure 3.1 and Figure 3.2. The material had a fully martensitic structure with a prior austenitic grain size of $20 \pm 5 \mu\text{m}$. The Vickers macro hardness was about $220 \pm 1 \text{ HV}$.

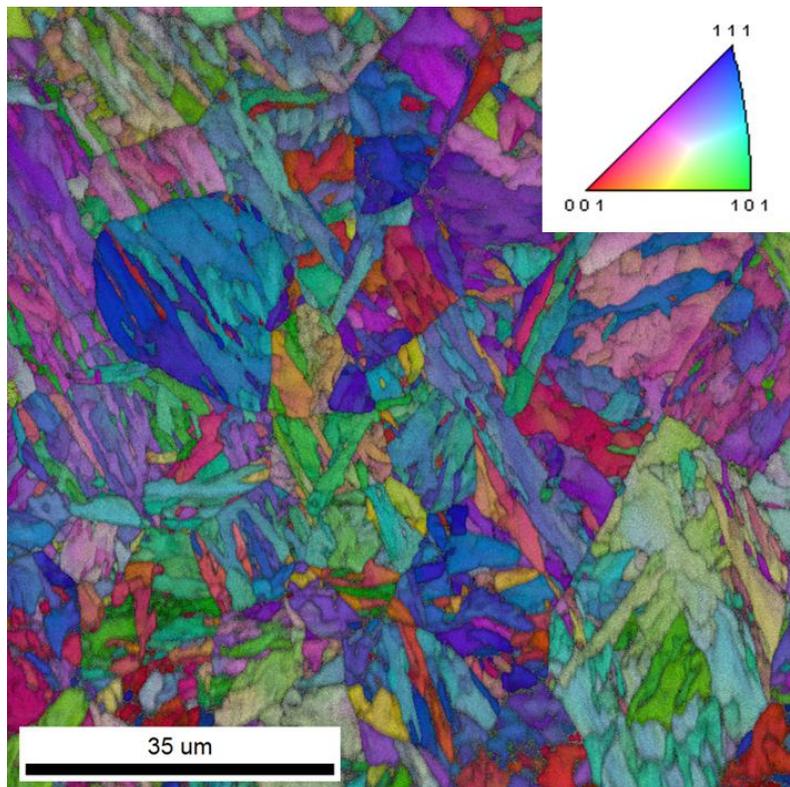
Figure 3.2: EBSD analysis of the as-received T91 material.

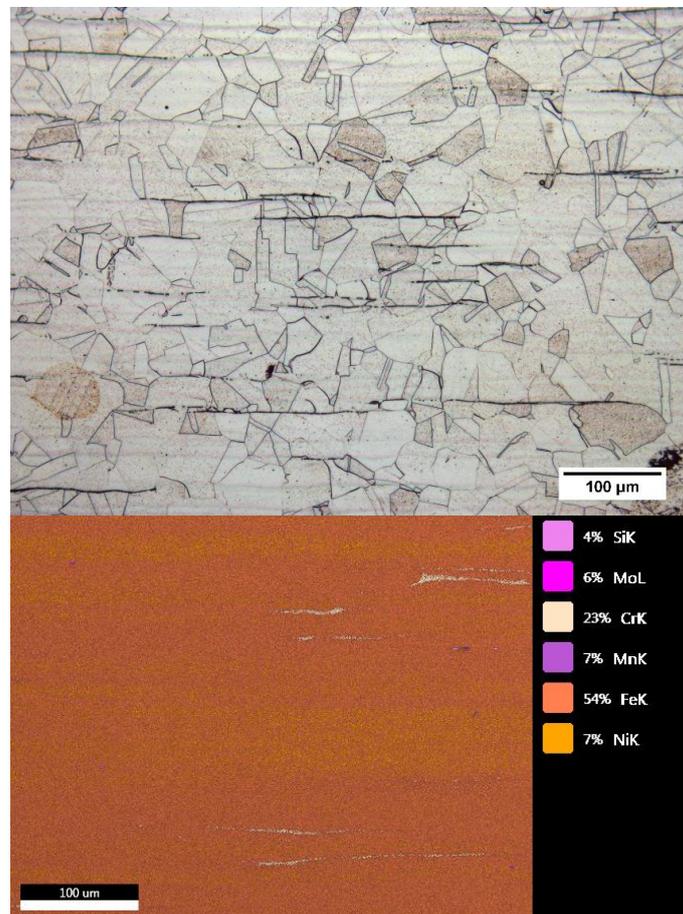
Figure 3.3: (Top) Typical microstructure of the tested 316L material, (Bottom) EDX mapping of a random area of tested 316L material

The 316L material was examined metallographically by optical and scanning electron microscopy equipped with energy dispersive X-Ray analysis. Optical micrographs are shown in Figure 3.3 and Figure 3.4. A fully austenitic microstructure interrupted with a small fraction of delta ferrite is evident. The large scale EDS mapping reveals some chemical banding with Ni fluctuation over hundreds of μm at the % level (Figure 3.3b). Furthermore a small number of annealing twins can be identified. In spite of stress relieving heat treatment a secondary phase was found along austenite grain boundaries in the rolling direction ((Figure 3.3 - Figure 3.5).

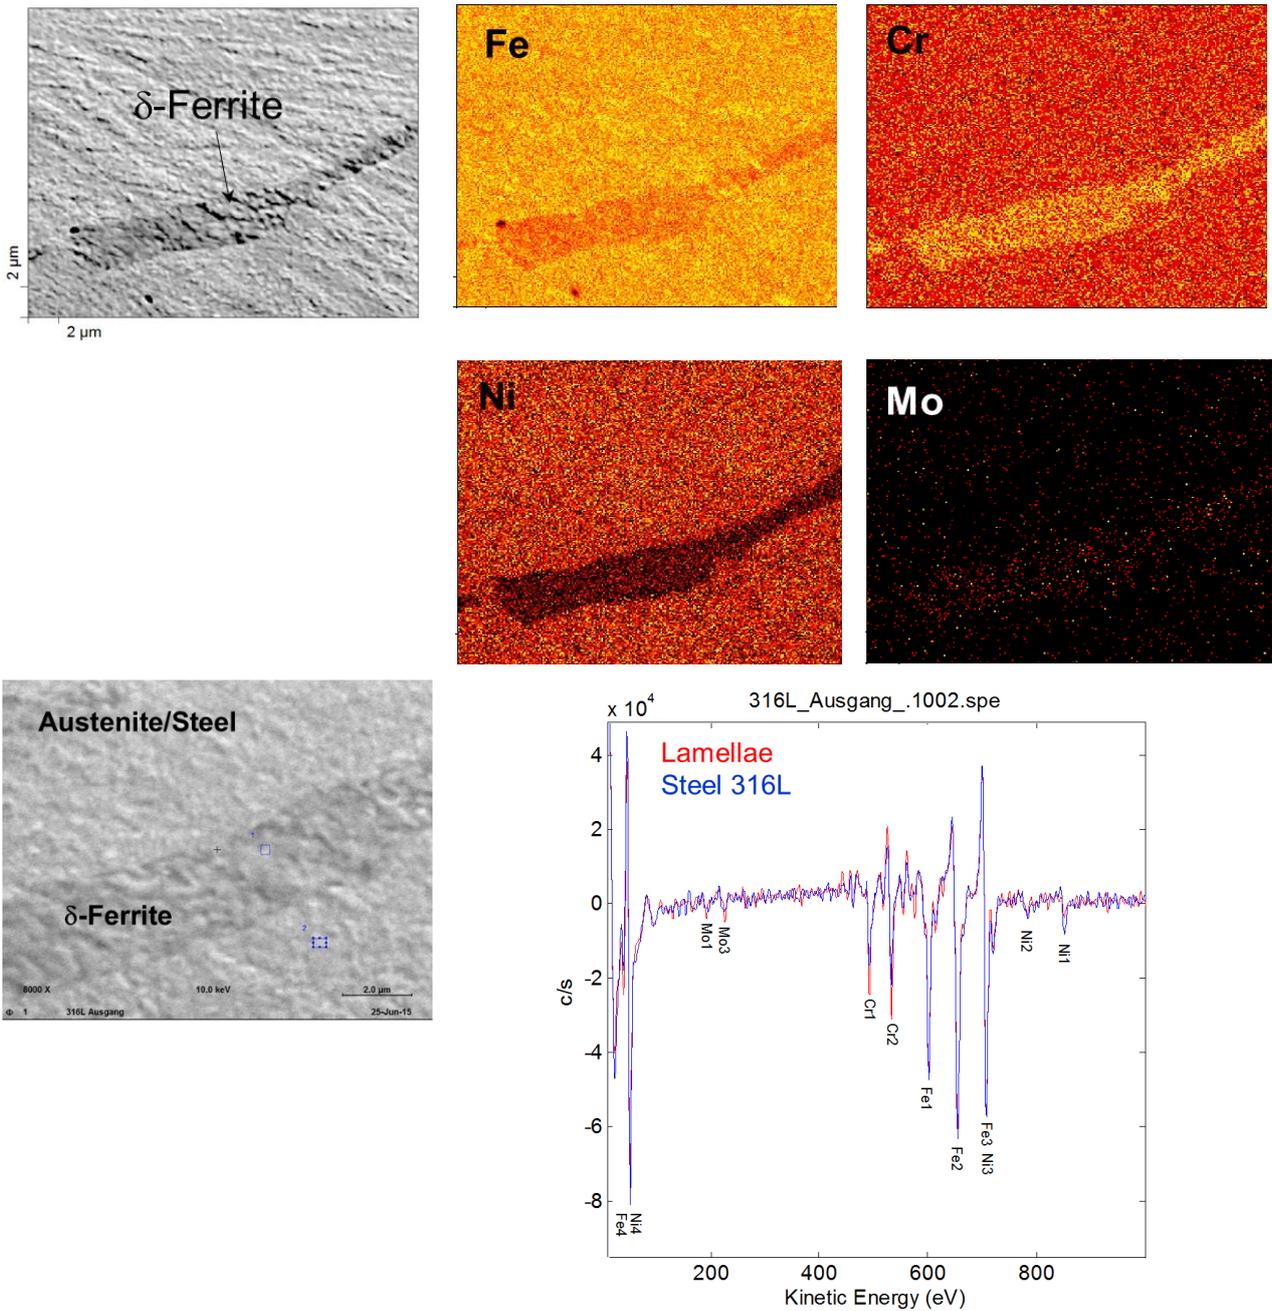
Figure 3.5: SEM/EDX mapping and Auger spectroscopy of 316L in as-received state.

Lamellas texture is enriched in Cr and slightly in Mo, as well as depleted in Fe and Ni in comparison to the austenite matrix (Figure 3.5). This is a sign of delta-ferrite formed during the fabrication of the steel.

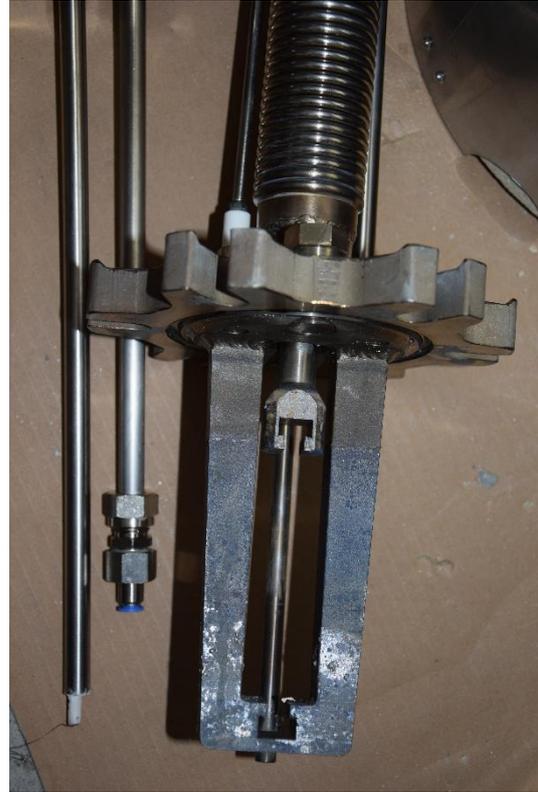
Figure 3.9: Testing frame of CALLISTO cell, common fitting for various adapters.

Tests in Centrum vyzkumu Rez (CVR) were carried out in the CALLISTO cell, a vessel containing PbBi (LBE) built on a Zwick/Roell Electromechanical Creep Testing machine, Kappa 50DS (Figure 3.8). CALLISTO is based on the 2-vessel concepts, where the first container is for the preparation of the liquid metal (rough oxygen dosing). The liquid is then transferred to the second preheated tank, containing holders and specimens. The testing frame (Figure 3.9) is common for alignment of all tested specimens.

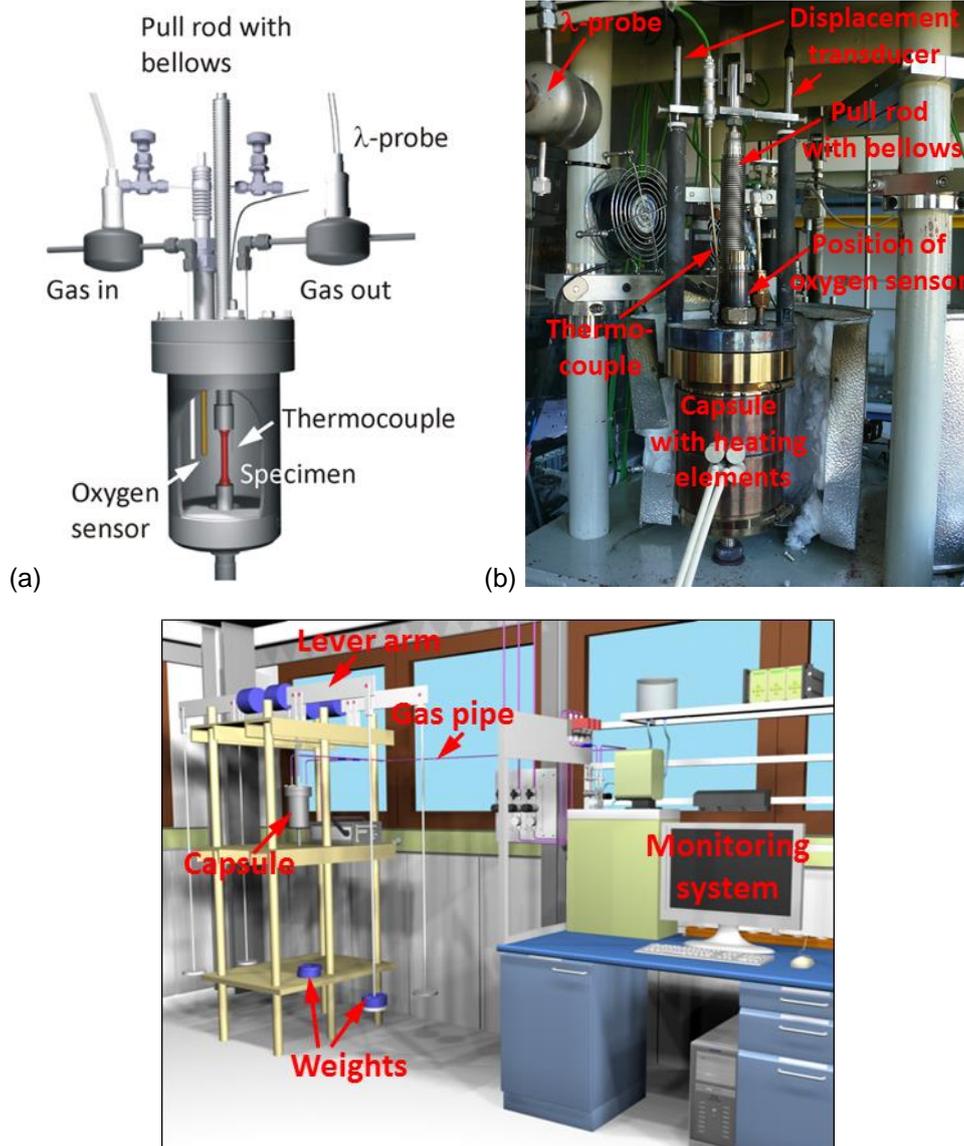
Figure 3.15: CRISLA-capsule for creep tests in heavy liquid metal (a, b) and CRISLA facility inclusive peripheral devices (c).

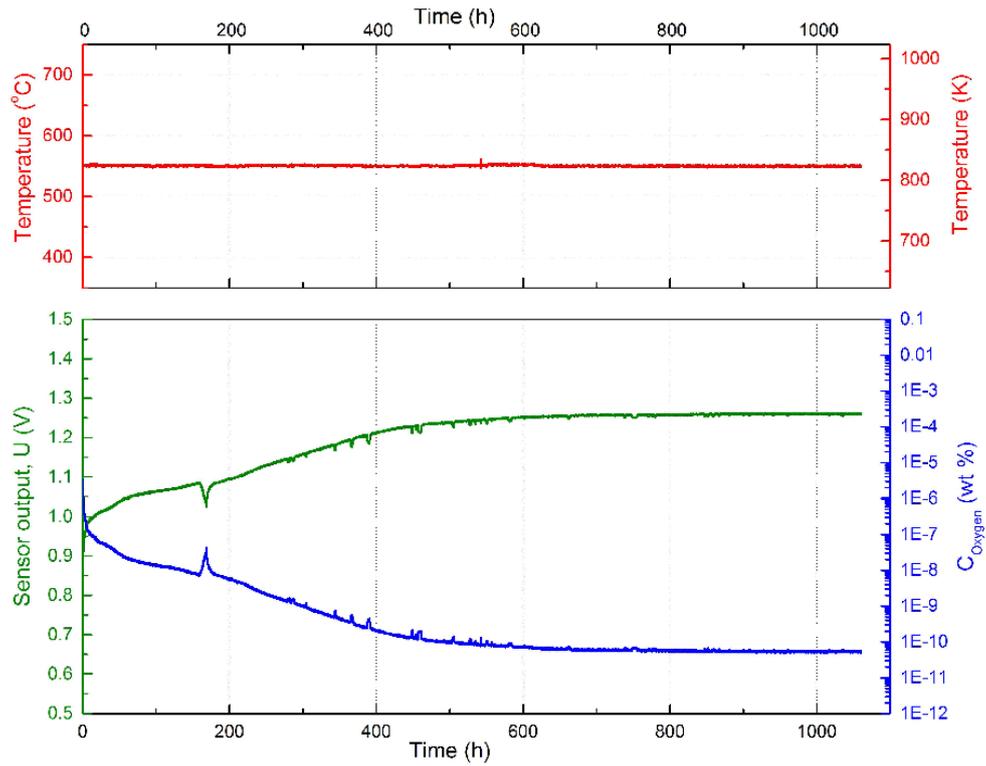
Figure 3.16: Test conditions – temperature of LBE, oxygen activity and oxygen concentration during the creep-to-rupture test with 316L at 550°C.

Test conditions are presented in Figure 3.16 to Figure 3.19.

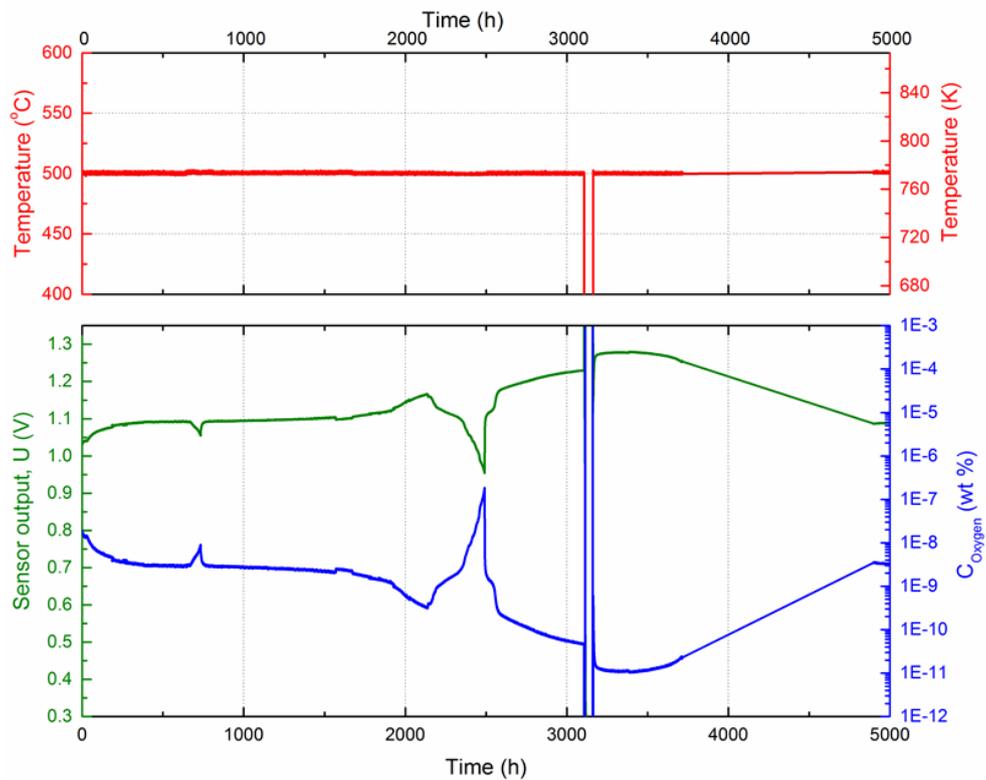
Figure 3.17: Test conditions – temperature of LBE, oxygen activity and oxygen concentration during the creep-to-rupture test with 316L at 500°C.

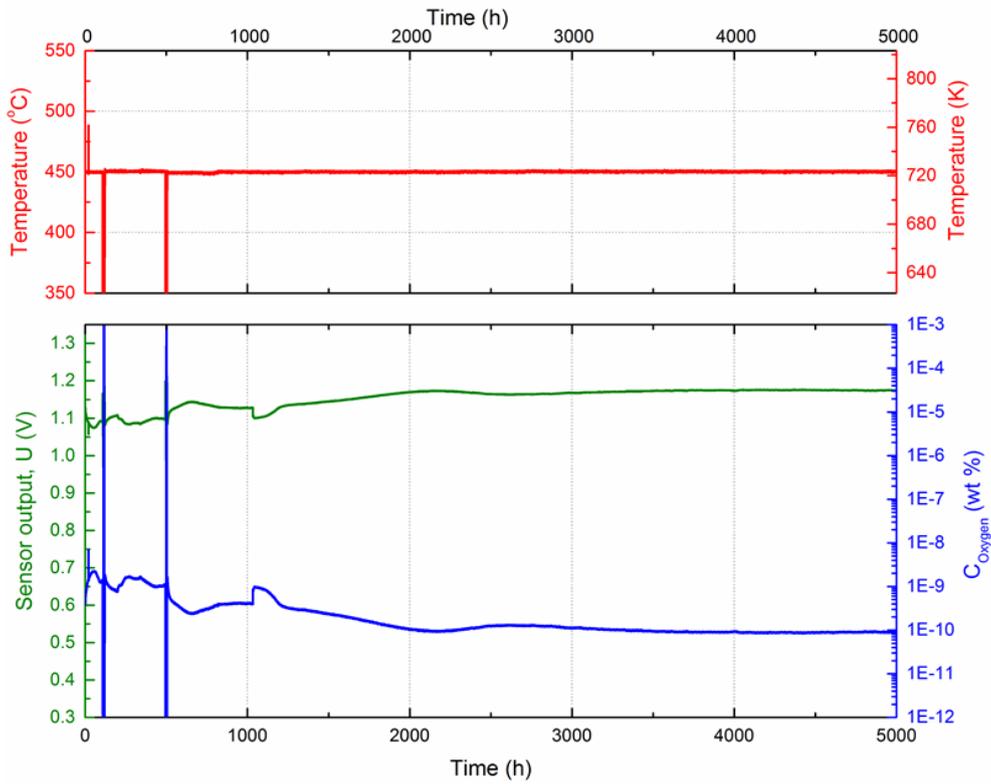
Figure 3.18: Test conditions – temperature of LBE, oxygen activity and oxygen concentration during the creep-to-rupture test with 316L at 450°C.

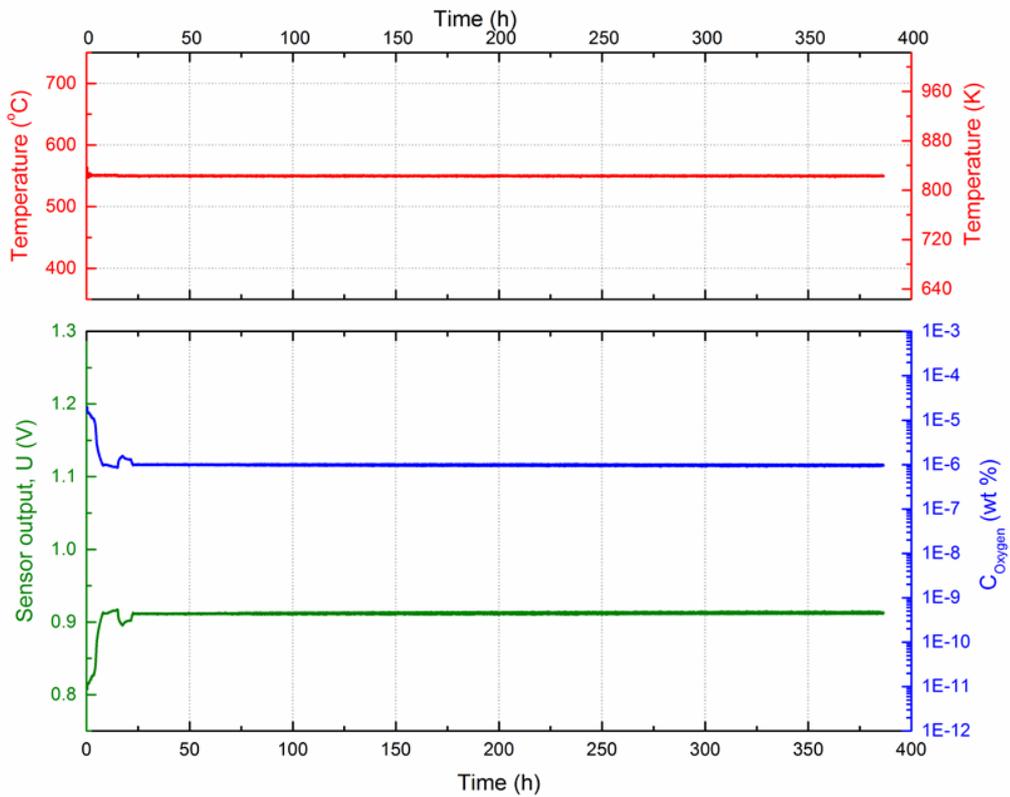
Figure 3.19: Test conditions – temperature of LBE, oxygen activity and oxygen concentration during the creep-to-rupture test with 316L at 550°C and $c_o=10^{-6}$ wt%.

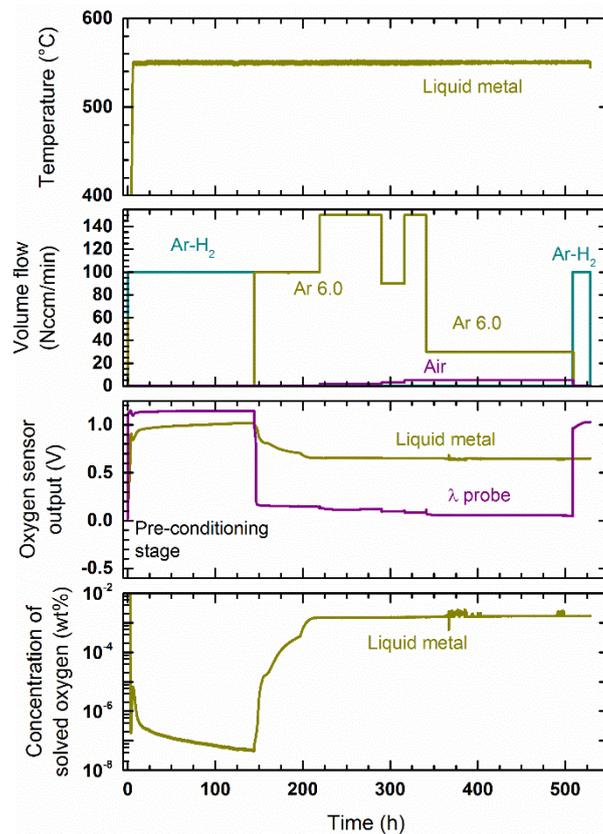
Figure 3.21: Functionality test of the oxygen Pt/air sensor in CRISLA equipment after the creep-to-rupture test with 316L in LBE at $c_o=10^{-6}$ wt%, 550 °C and 300 MPa.

The oxygen sensor has shown stability of the voltage output that corresponds to PbO formation during long term of introducing of air and oxygen containing Ar into LBE at the constant elevated temperature. An approaching of the measured oxygen sensor output and the theoretical value of lead oxide formation allows us to be virtually certain that the oxygen sensor used by constant oxygen concentration in liquid metal $c_o=10^{-6}$ wt% displayed a real voltage before its functionality test as well.

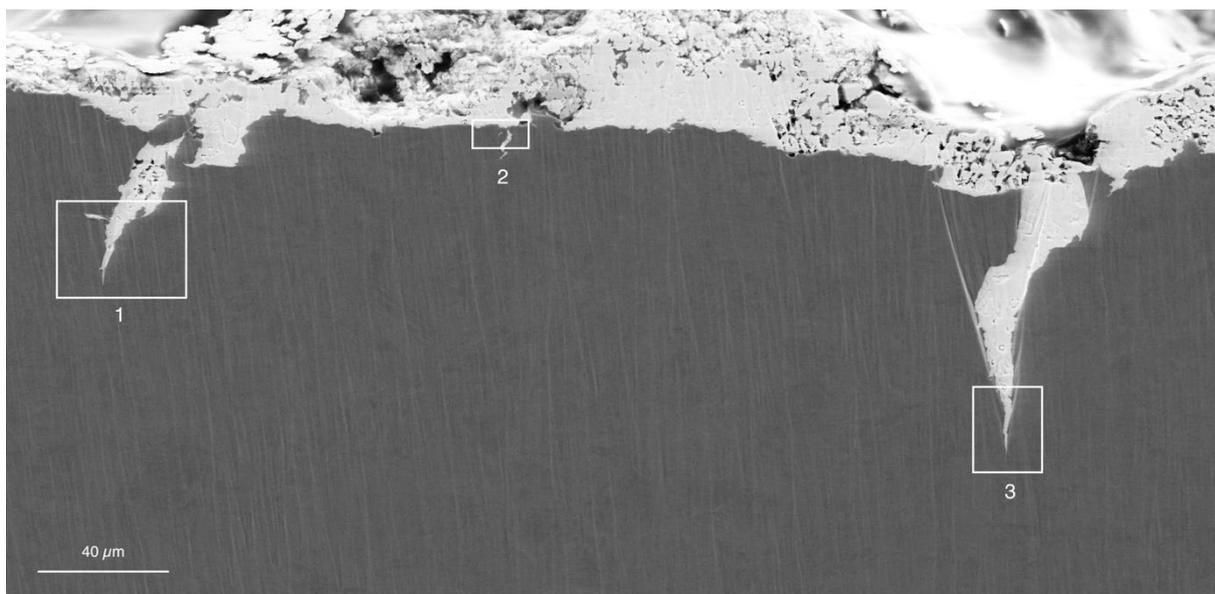
Figure 3.23: BSE view of the cut from Sample 3 with the areas analyzed by EBSD

Starting from the notch each specimens fracture surface has in the following order, a precracked area, a crack propagation area (sample 2 excluded) and the remaining area broken in liquid nitrogen. The EBSD ready area of sample 1 was milled in the part of the specimen that was broken in liquid nitrogen after testing in air. This gave the opportunity to study the low temperature brittle fracture mode of the steel to compare with the brittle fracture induced by LBE. Sample 2 was prepared for EBSD in the area of pre-cracking by fatigue in LBE. Sample 3 was prepared for EBSD in the area of crack propagation in liquid LBE. Sample 2 and sample 3 still had their fracture surface covered with LBE which was then protected from potential manipulation damage and eased imaging (LBE appears in white contrast in Back Scattered Electron (BSE) mode imaging, see Figure 3.23).

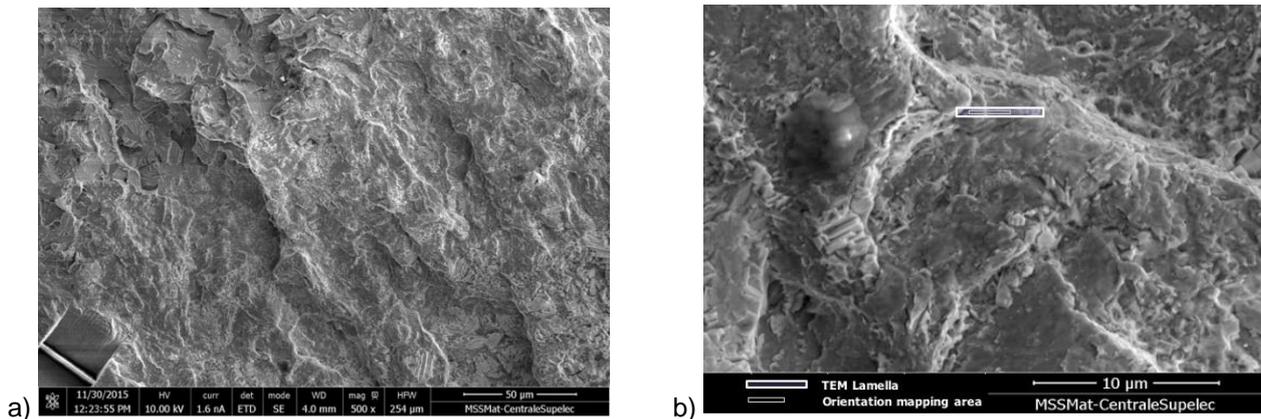
Figure 3.24: SEM view of the area from Sample 4 selected for FIB sampling a) general view of the fractured area for FIB sampling (notice the fracture surface in liquid nitrogen at the top left) b) detailed view of the area of FIB sampling with the step and the rectangular shape deciphering the area under investigation

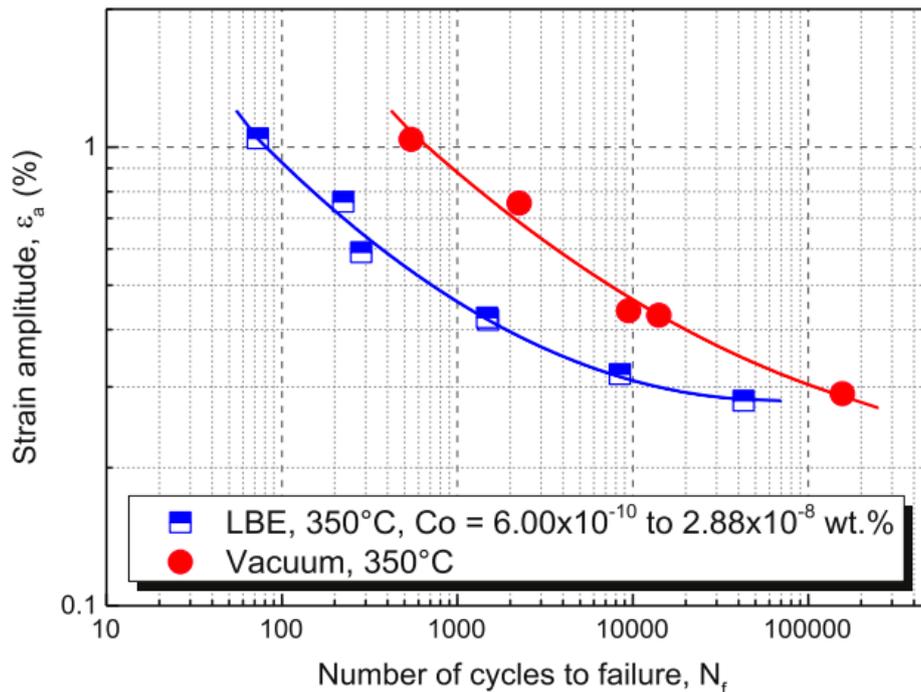
Figure 4.1: Comparison of the fatigue lives for T91 tested in vacuum and tested in LBE [33].

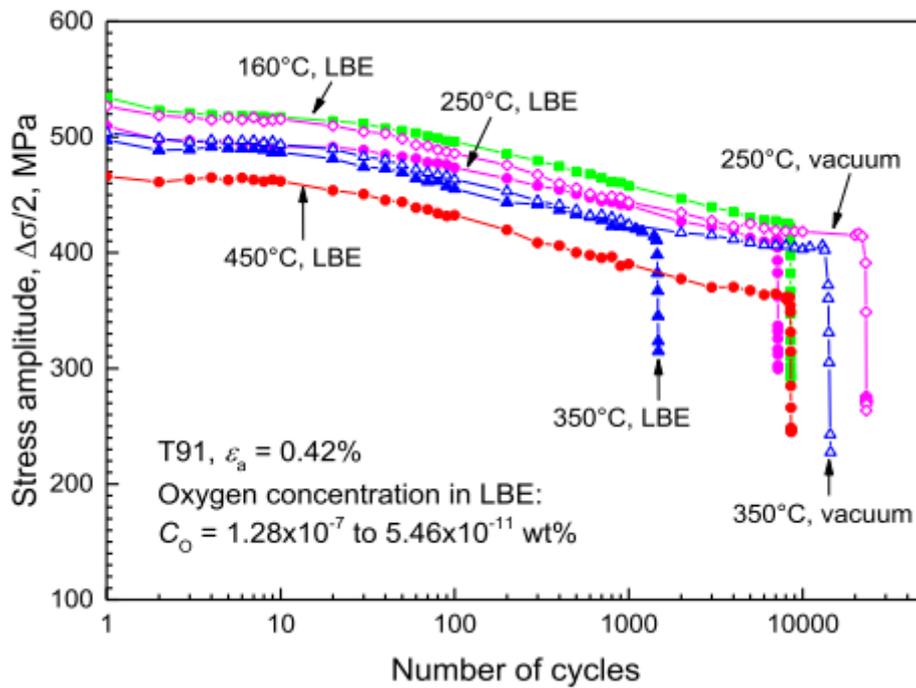
Figure 4.2: Cyclic stress response of T91 as function of temperature tested in LBE and vacuum [44].

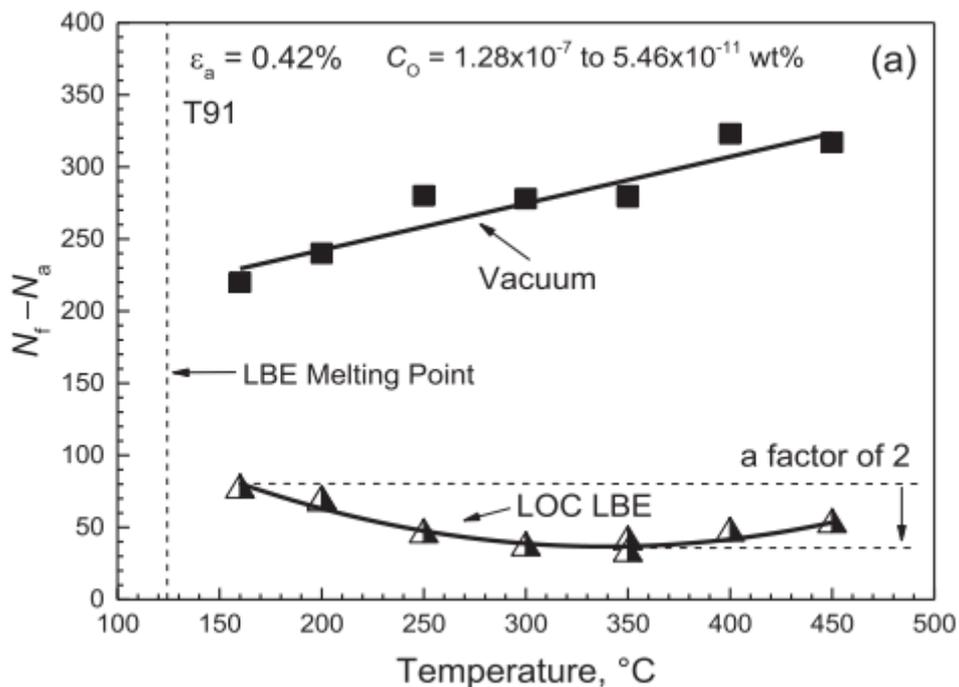
Figure 4.3: Effect of temperature on $N_f - N_a$ illustrating the temperature influence on fatigue crack propagation [44].

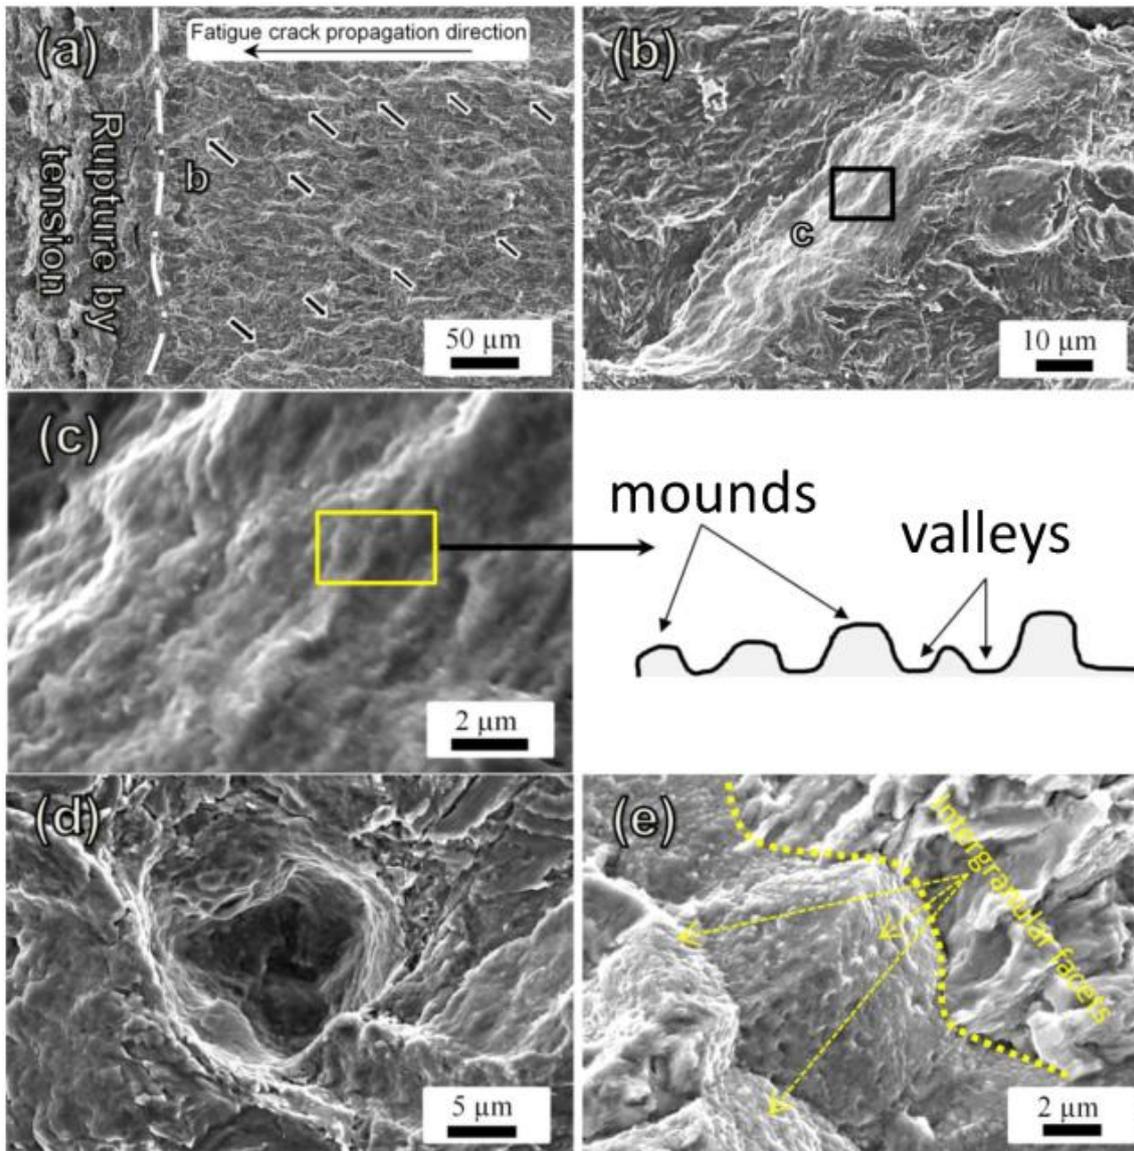
Figure 4.4: SEM fractographic micrographs show a typical quasi-brittle fracture surface after testing in LBE, covered by many tear ridges (a and b) on which submicron “mounds/valleys” are present (c); A large dimple with a size of 15 μm can be observed as well (d); Many submicron “mounds/valleys” are present on the intergranular facets (e). The T91 specimen in (a–d) was tested under the conditions: $T = 350\text{ }^{\circ}\text{C}$, $\epsilon_a = 0.76\%$, $C_O = 5.8 \times 10^{-9}\text{ wt.}\%$; The T91 specimen in (e) was tested at $160\text{ }^{\circ}\text{C}$, $\epsilon_a = 0.43\%$, $C_O = 3.80 \times 10^{-9}\text{ wt.}\%$ [45].

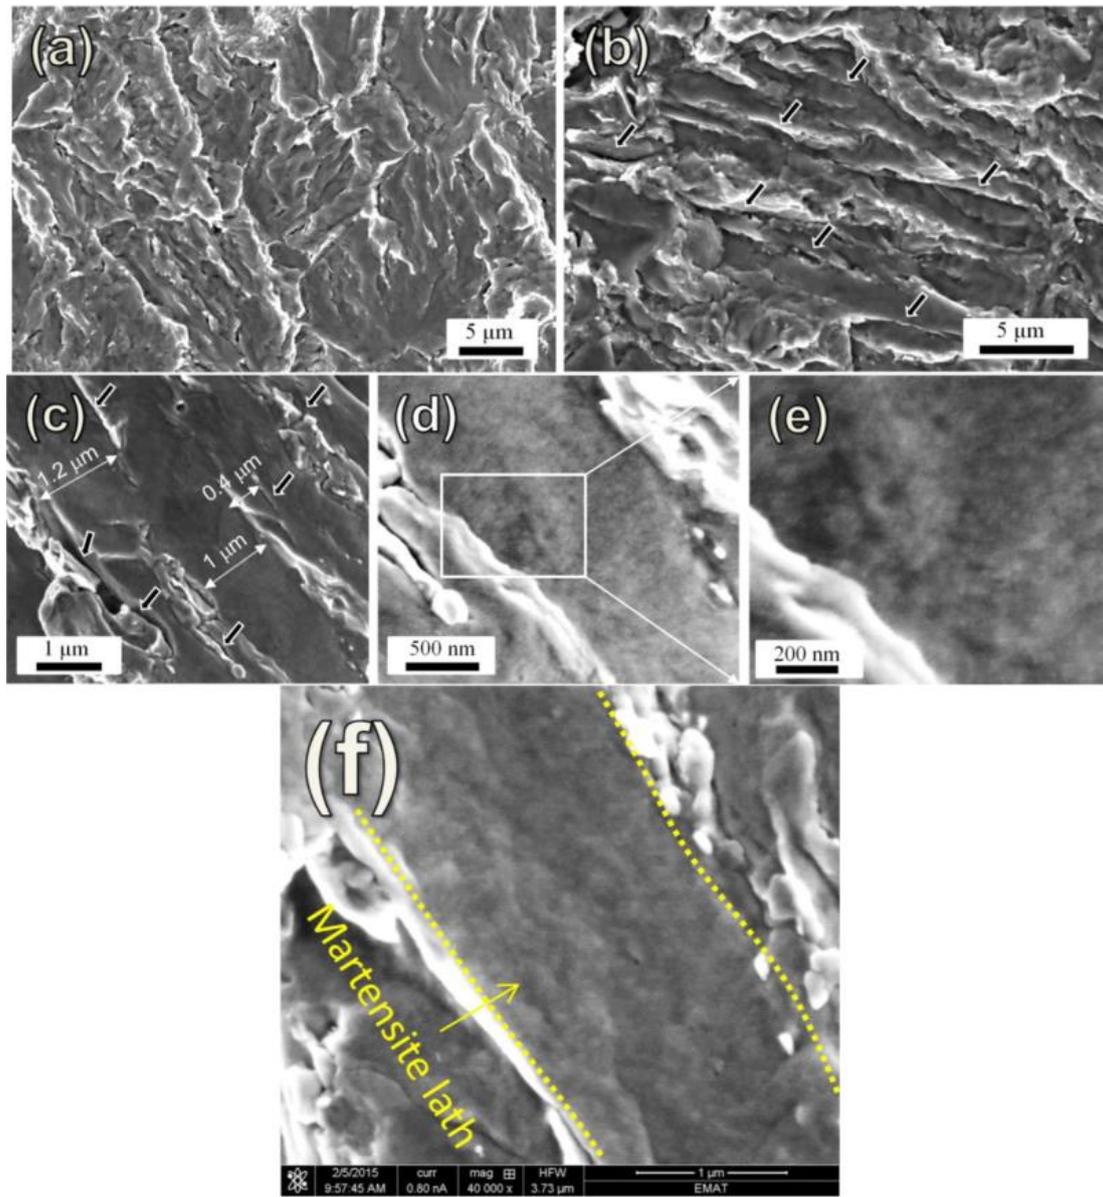
Figure 4.5: High resolution SEM fractographic micrographs showing very rough fracture surface after testing in LBE, characterized by numerous tiny secondary cracks and flat “featureless” regions (a and b); The tiny secondary cracks seem to propagate along the martensite lath boundaries (b and c); The flat regions are not perfectly featureless but are covered by a large number of nano “mounds/valleys” (d–f). The arrows indicate the positions of the secondary cracks. The T91 specimen in (a) was tested under the conditions: $T = 350\text{ }^{\circ}\text{C}$, $\epsilon_a = 0.59\%$, $C_O = 2.88 \times 10^{-8}\text{ wt.}\%$; The T91 specimen in (b–f) was tested under the conditions: $T = 350\text{ }^{\circ}\text{C}$, $\epsilon_a = 0.76\%$, $C_O = 5.8 \times 10^{-9}\text{ wt.}\%$ [45].

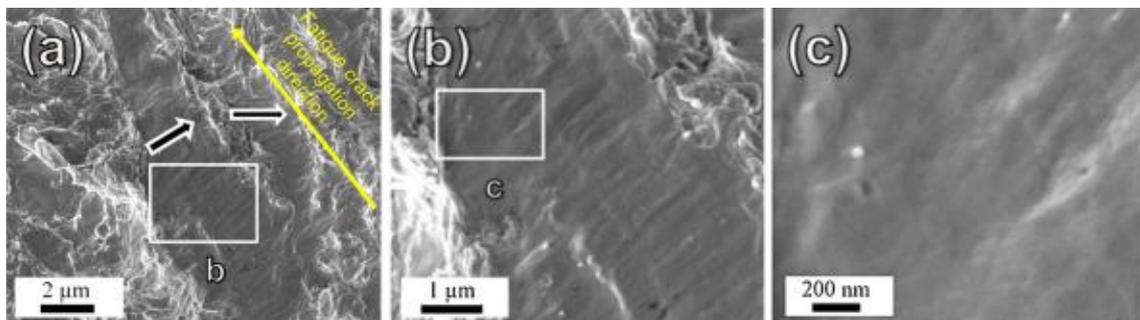
Figure 4.6: High resolution SEM fractographic micrographs of the LME fracture surface showing that the flat regions do not have as evident nanoscale dimples as those shown in Fig. 4e. The SEM pictures were taken under a tilt angle to show the relative position of two adjacent flat regions, as indicated by the two arrows (a). More details at the flat regions are shown in (b and c). The T91 specimen was tested under the conditions: $T = 350\text{ }^{\circ}\text{C}$, $\epsilon_a = 0.76\%$, $C_O = 5.8 \times 10^{-9}\text{ wt.}\%$ [45]

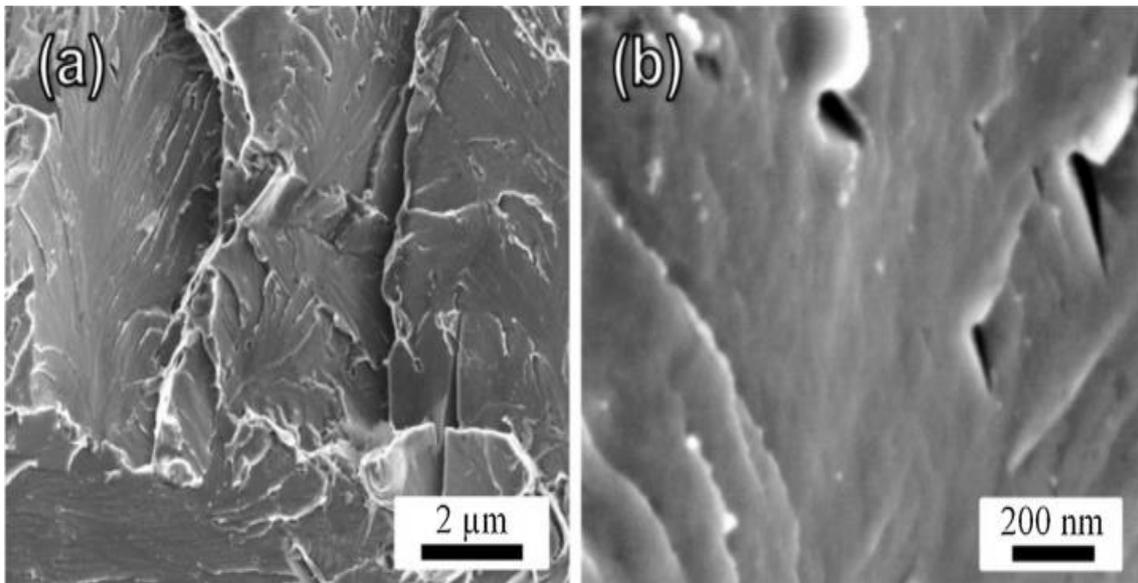
Figure 4.7: High resolution SEM micrographs of a cleavage fracture surface of T91 steel, generated by fracturing in liquid nitrogen, showing river patterns and brittle facets (a) and the absence of the nanoscale dimples lower than 10 nm (b). [45]

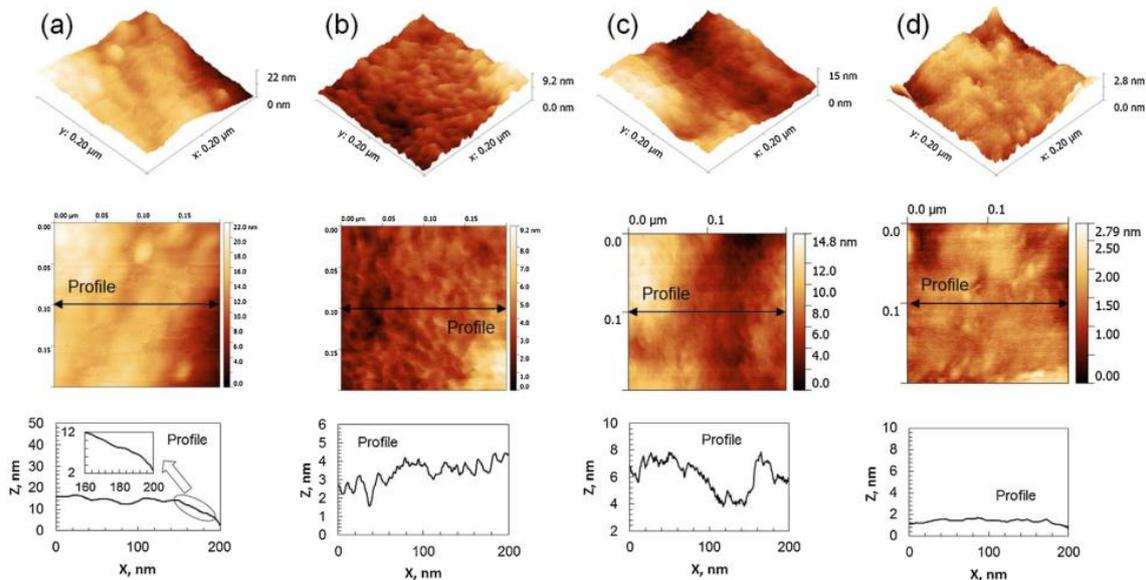
Figure 4.8: AFM topographic images of fracture surfaces: (a) fracture surface created in liquid N₂; (b and c) fatigue fracture surfaces generated in the presence of LBE under the following conditions: T = 350 °C, $\epsilon_a = 0.74\%$, $C_o = 6 \times 10^{-10}$ wt.%; (d) the fracture surface created in liquid N₂ and then exposed to LBE at 350–280 °C for about 4 h. [45]

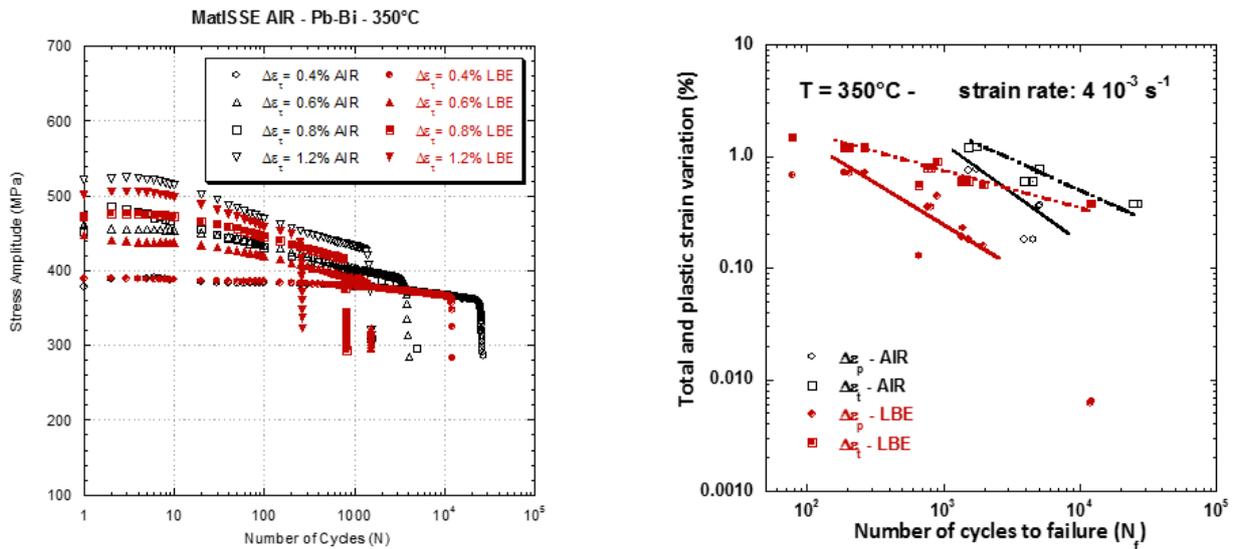
Figure 4.9: Comparison of fatigue results of T91 steel at 350 °C in LBE and air.

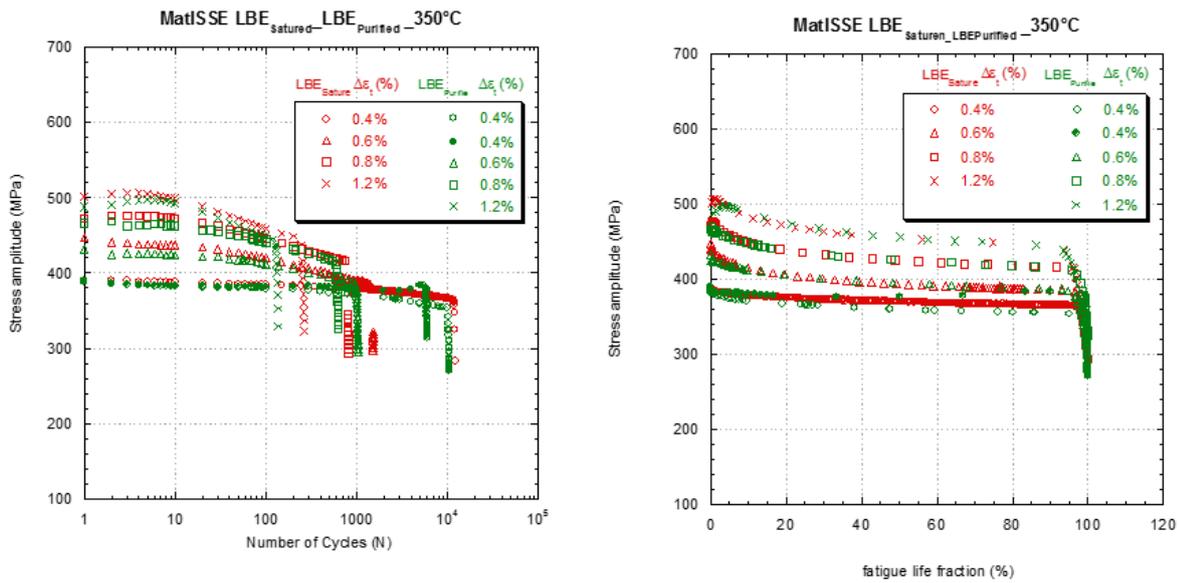
Figure 4.11: Comparison of fatigue results of T91 steel at 350 °C in saturated and purified ($c_o=10^{-7} - 10^{-9}$ wt%) LBE.

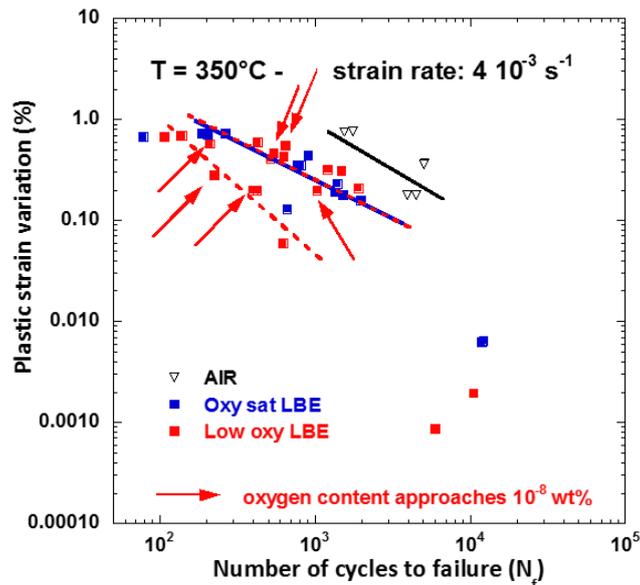
Figure 4.12: Comparison of fatigue results of T91 steel at 350 °C.

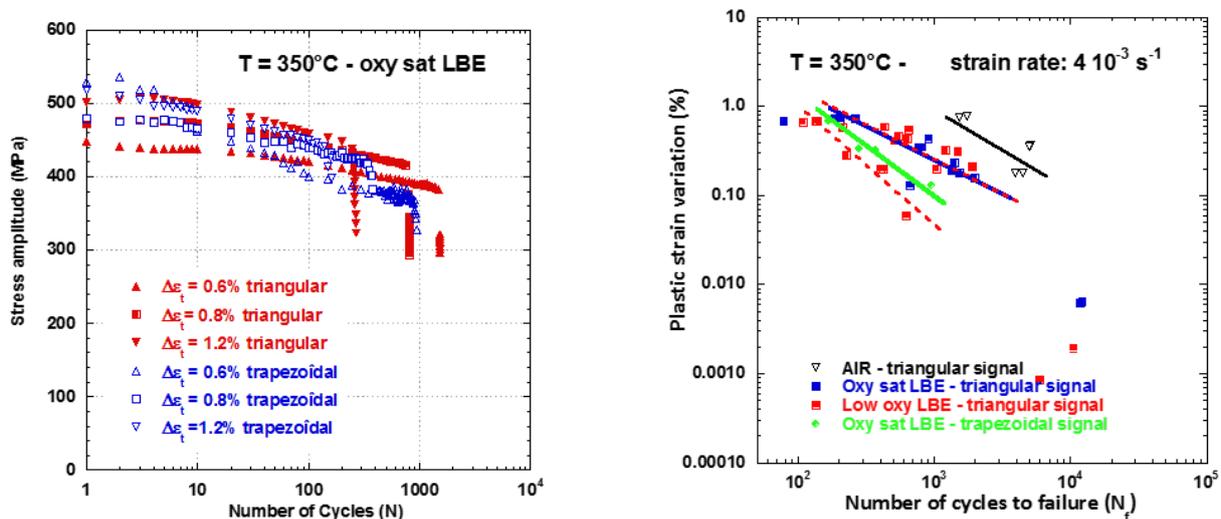
Figure 4.14: Comparison of fatigue results of T91 steel at 350 °C for different types of strain rate

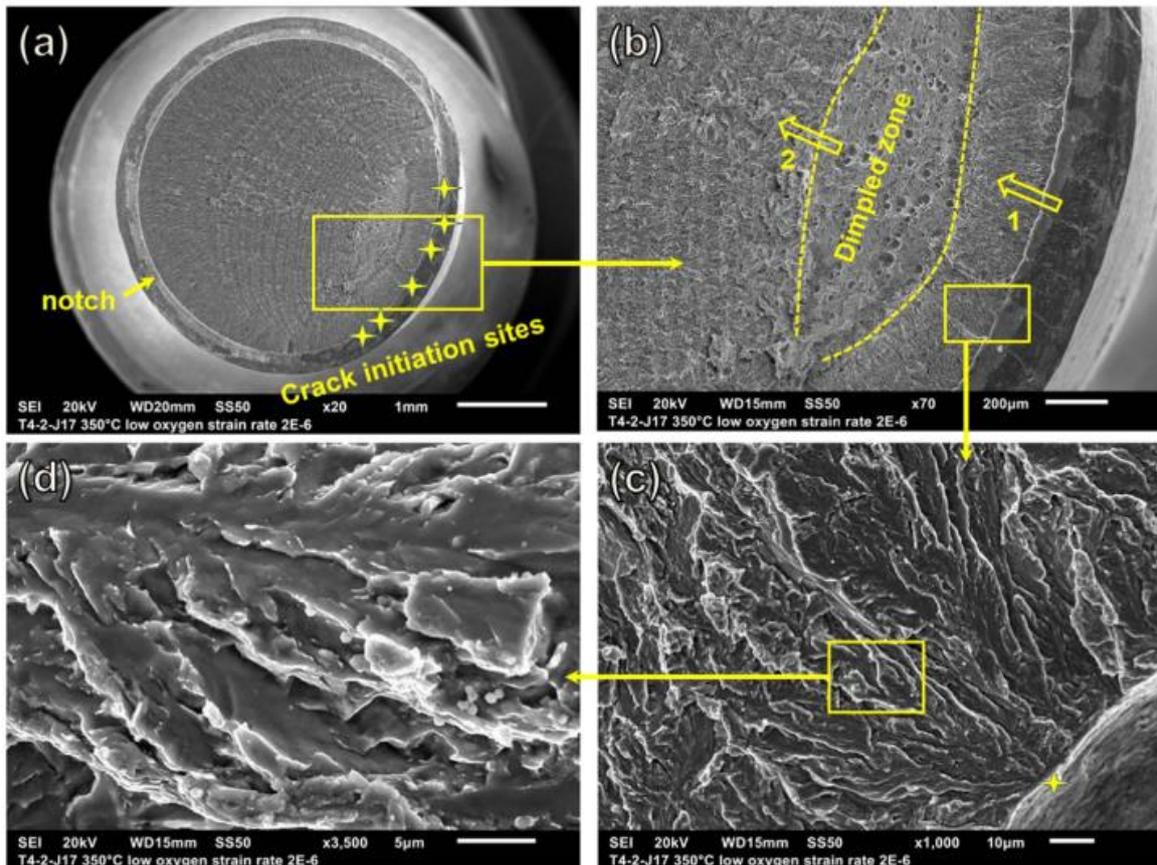
Figure 4. 15: Fractography of the fracture surface of a notched T91 tensile sample tested in low oxygen LBE at 350°C [46].

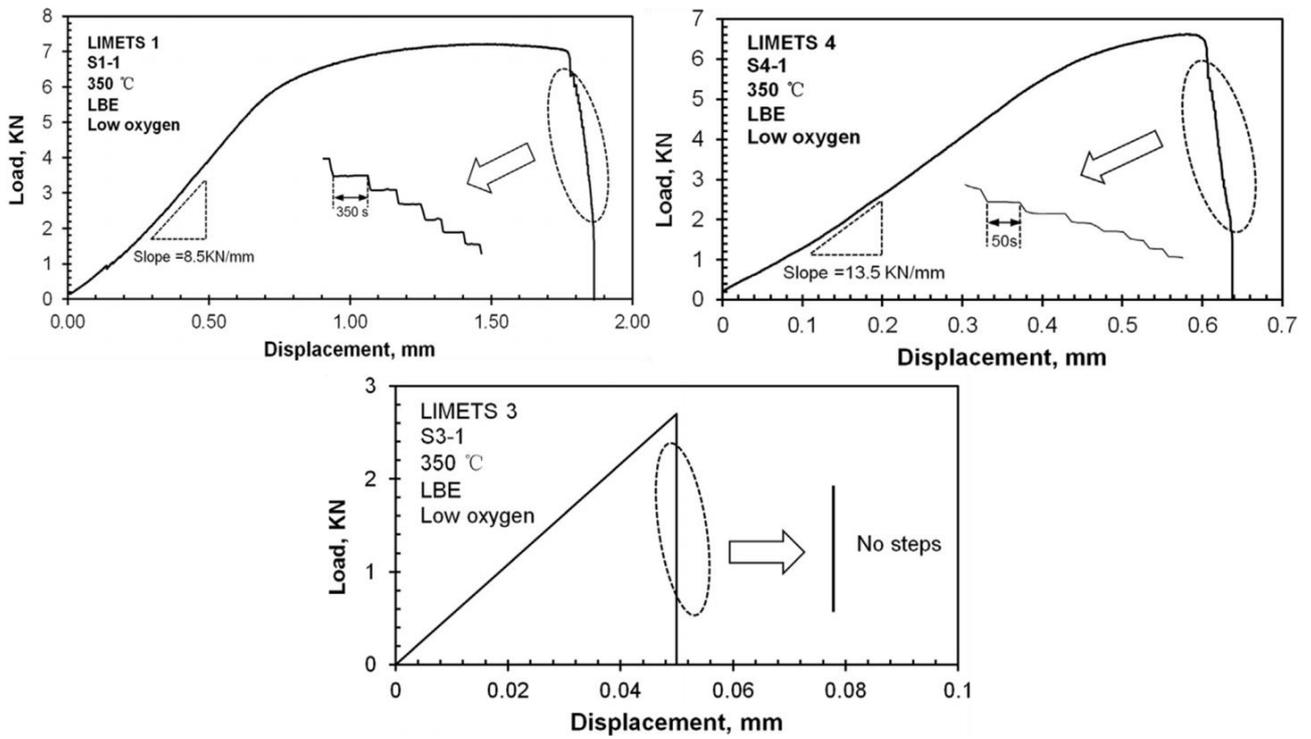
Figure 4.16: Comparison of stress strain curves for different tensile test machines [46].
