**Support to the development of joint research actions
between national programmes on advanced nuclear materials**

FP7-Fission-2013
Combination of Collaborative project (CP) and Coordination and Support Actions (CSA)

D.5.42

***Report for mech./microstr. character. of environ.
assisted degrade. effects of steels in lead alloys
and assess. of environm. degrad. effects on perf.
of struct. and funct. comp. of MYRRHA ADS &
LFR***

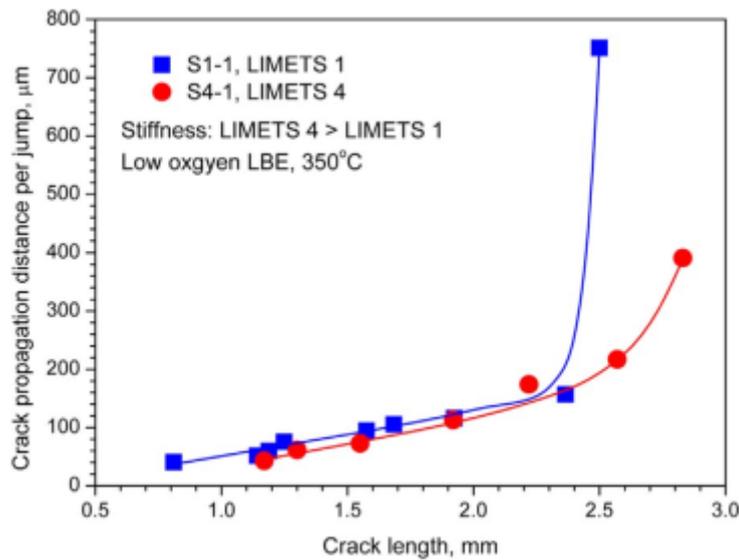
Figure 4.17: Crack propagation distance as function of crack length indirectly indicating the LME crack propagation rates [46].

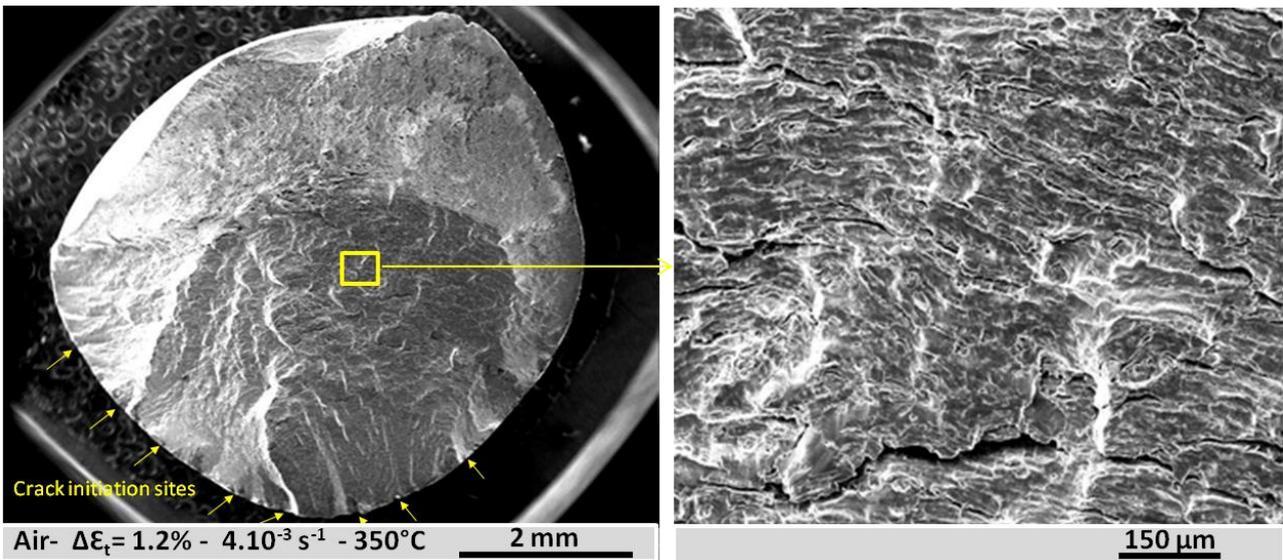
Figure 4.18: Fracture surface of T91 after fatigue test in the air at 350°C.

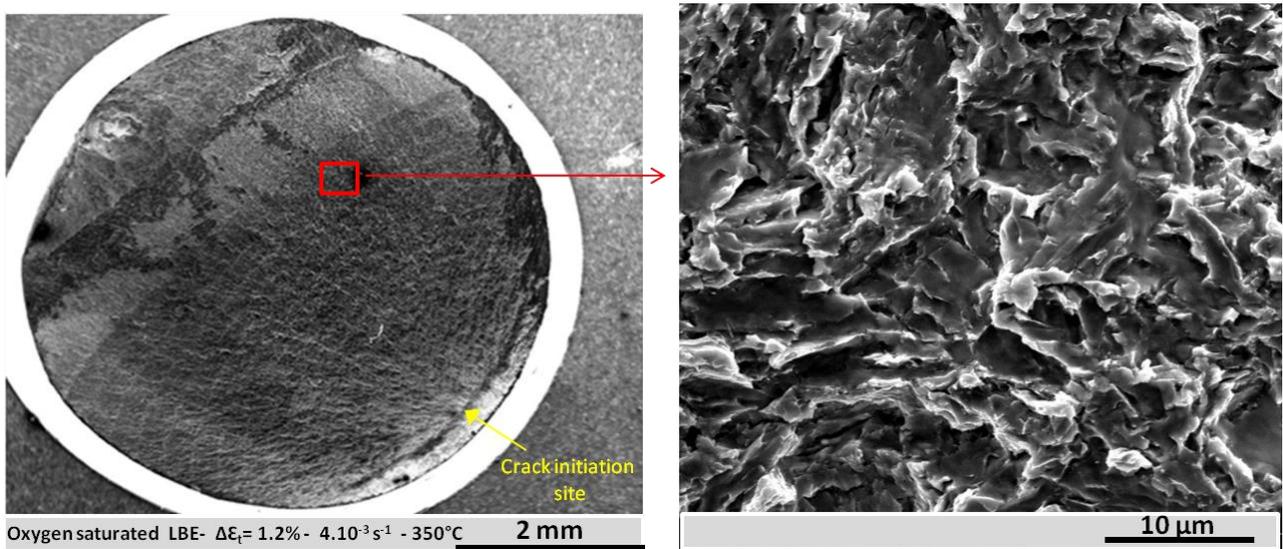
Figure 4.19: Fracture surface of T91 after fatigue test in saturated LBE at 350°C (strain rate $4 \cdot 10^{-3} \text{ s}^{-1}$) a) overview, b) detail out of a).

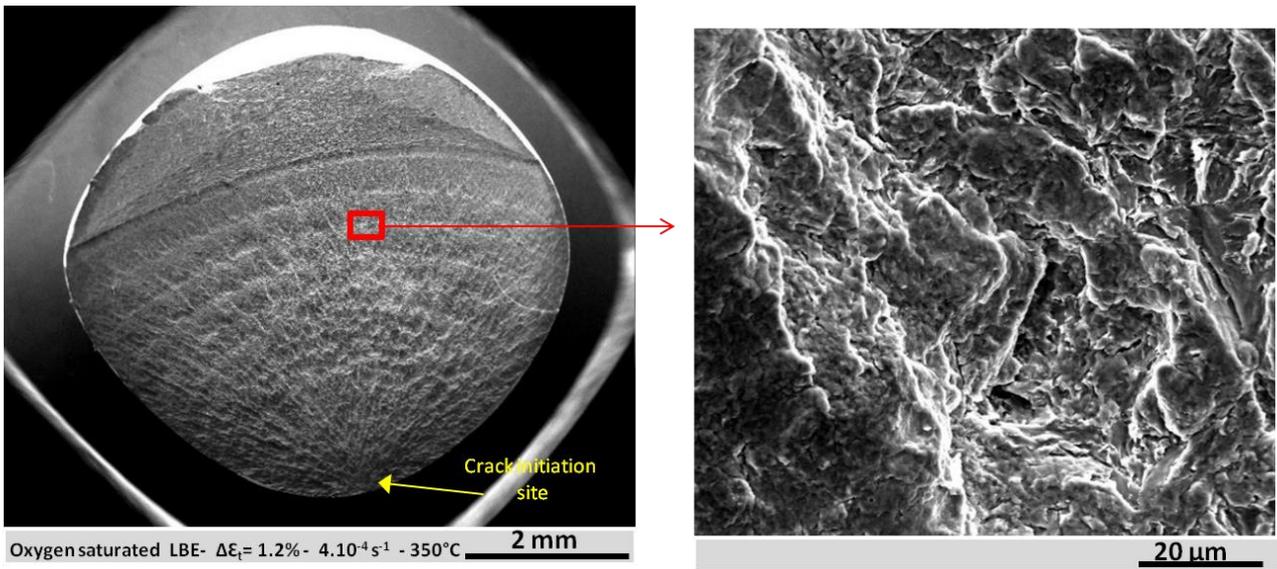
Figure 4.20: Fracture surface of T91 after fatigue test in saturated LBE at 350°C (strain rate $4 \cdot 10^{-4} \text{ s}^{-1}$) a) overview, b) detail out of a).

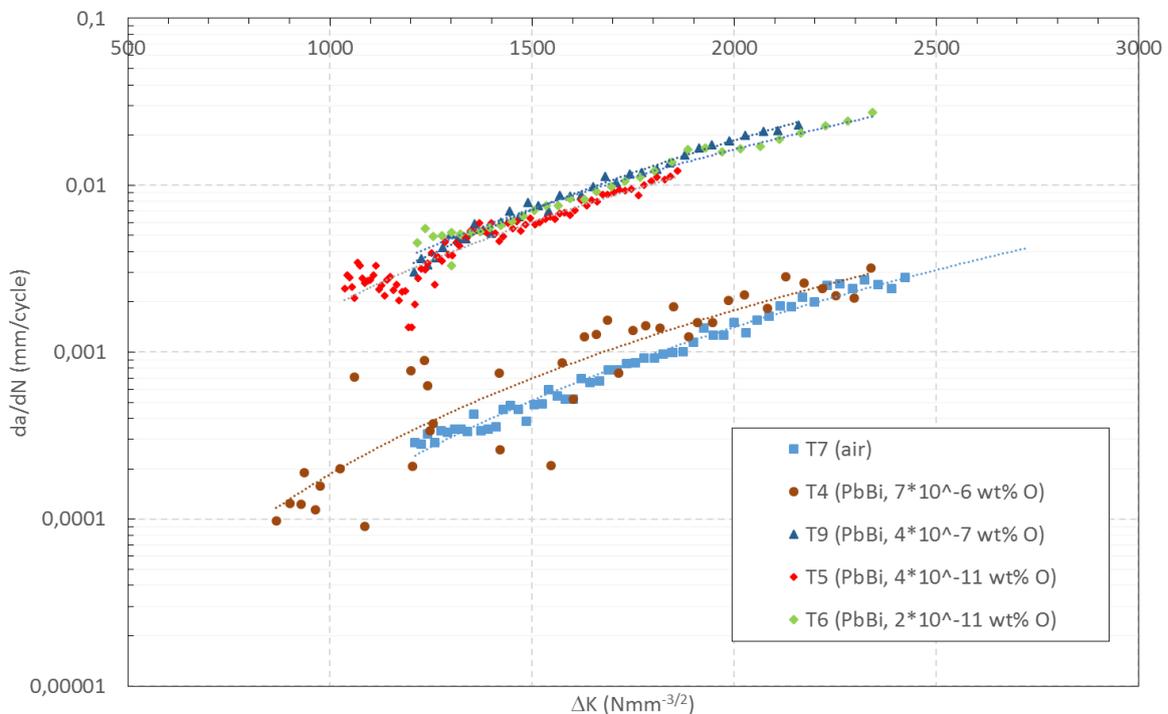
Figure 4.21: Fatigue crack growth of T91 steel at 300 °C comparing air and LBE environment.

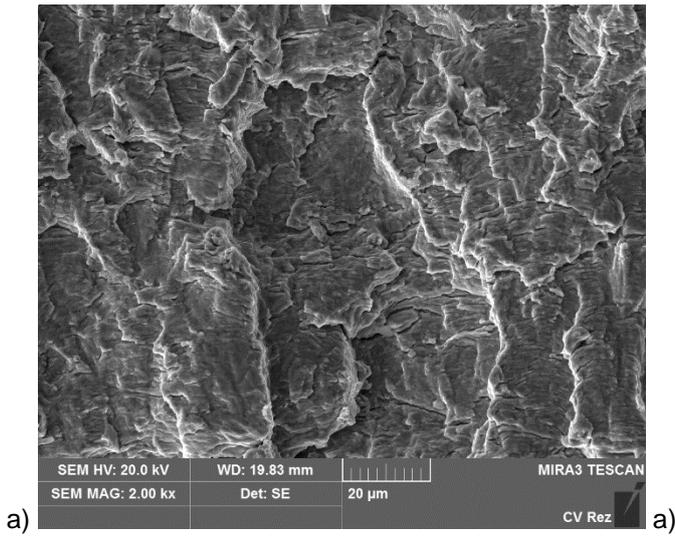
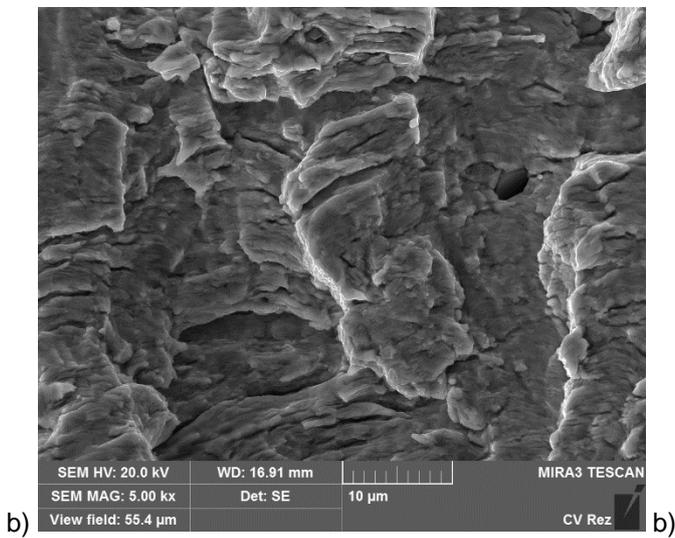
Figure 4.22: Sample CT-T7– steel T91, 300 °C, air:
(a) fracture area, (b) detail.

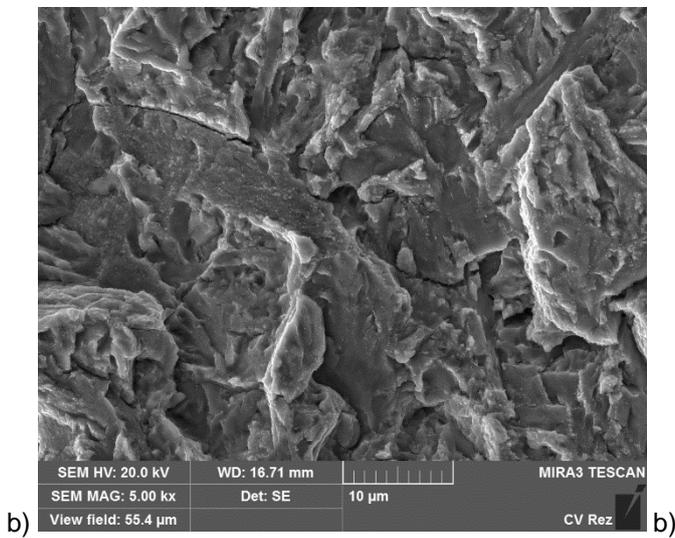
Figure 4.24: Sample CT-T9 – steel T91, 300 °C, PbBi, $c_o=4 \cdot 10^{-7}$ wt%: (a) fracture area, (b) detail.

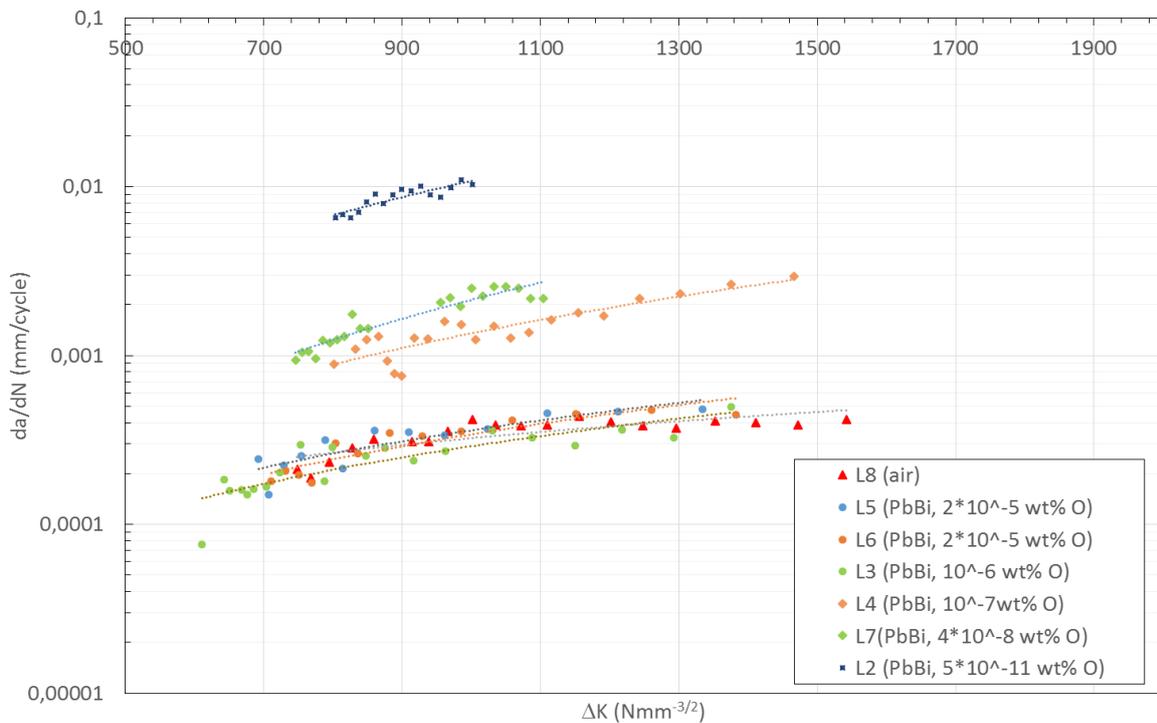
Figure 4.26: Fatigue crack growth of 316L stainless steel at 300 °C comparing air and LBE environment.

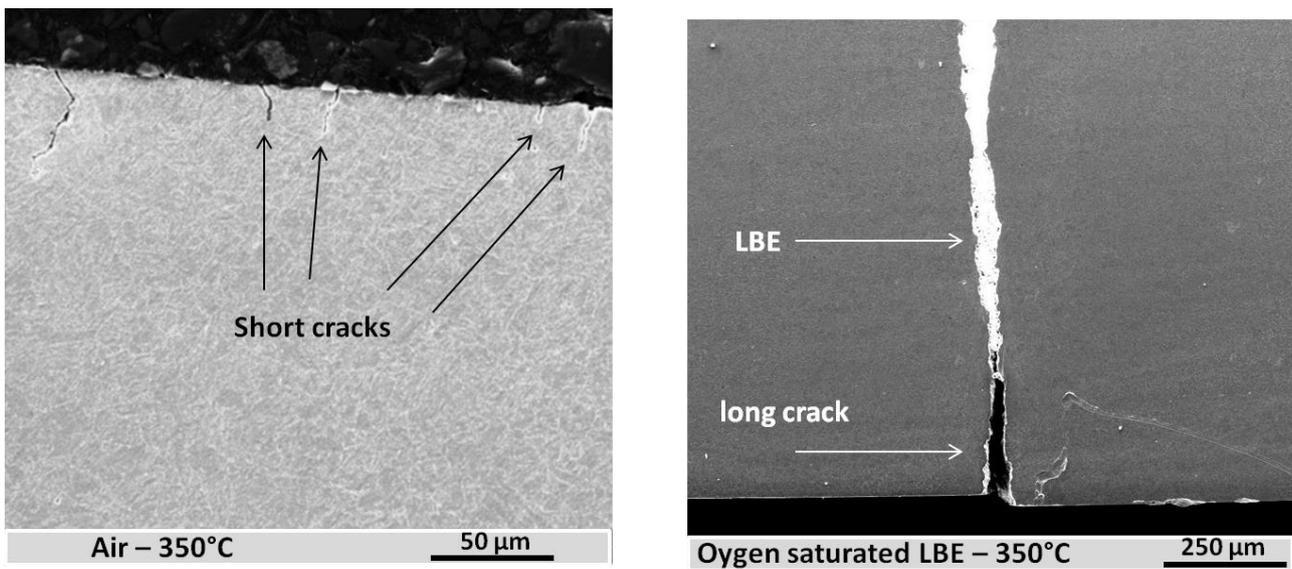
Figure 4.32: Comparison of cracks in cross sections of fatigue samples in T91 at 350°C in air and saturated LBE

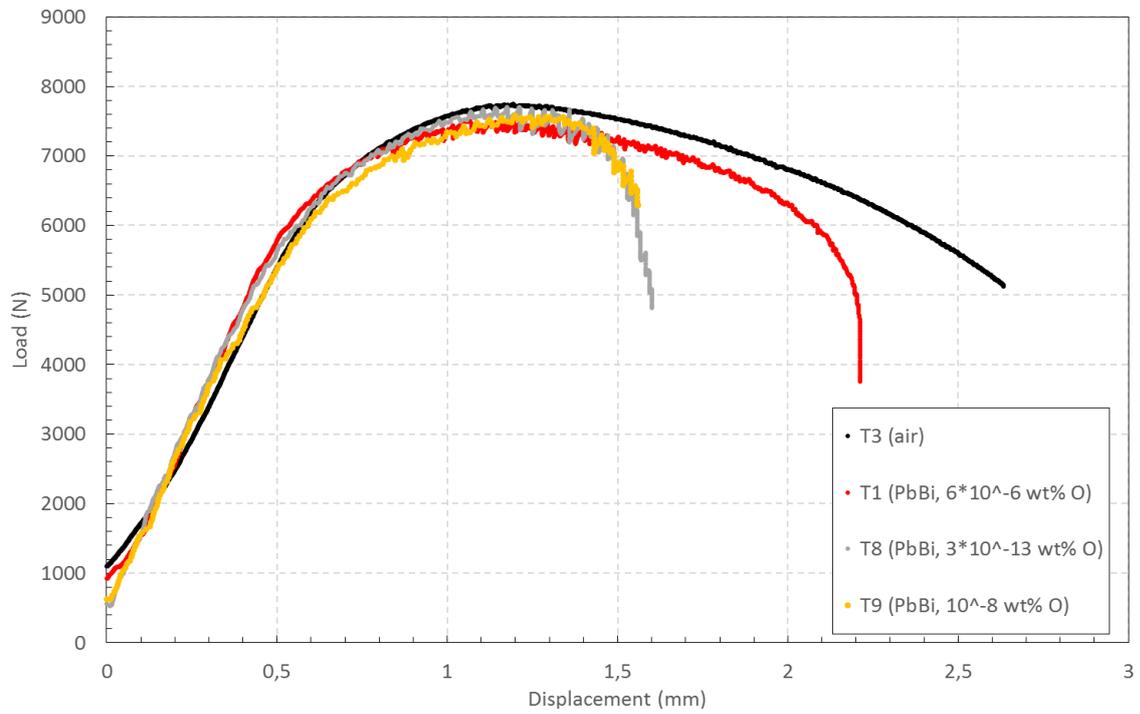
Figure 4.33: Comparison of load-displacement curves for T91 tapered specimens tested up to rupture at 300°C.

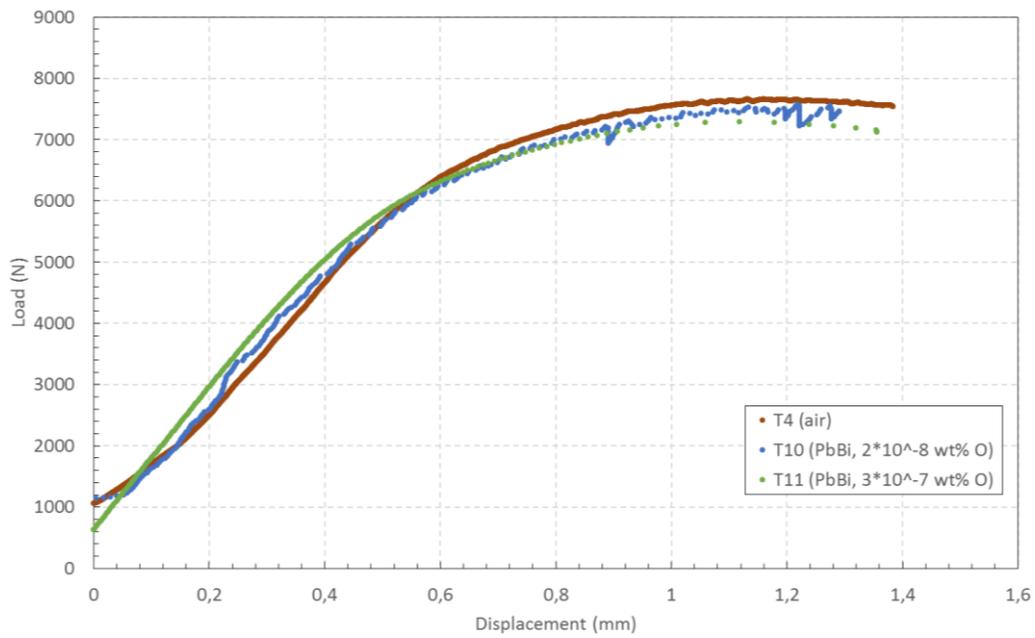
Figure 4.34: Comparison of load-displacement curves for T91 tapered specimens tested up to UTS at 300°C.

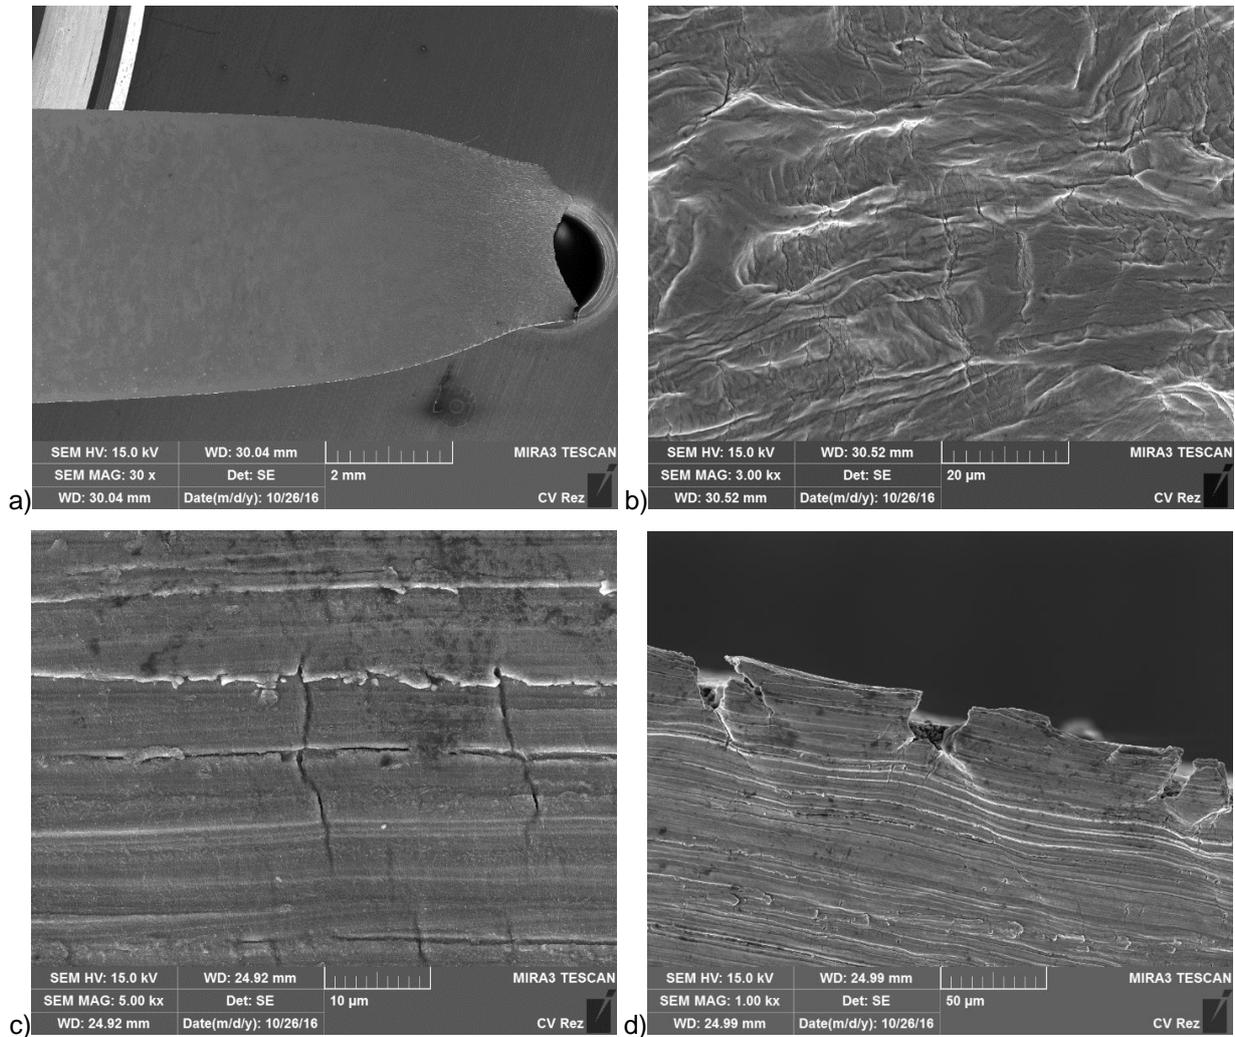
Figure 4.35: (a) T3, rupture (300°C, air), (b) detail of the polished side – ductile behavior of the necking, cracking perpendicular to the load direction, (c) detail of the ground side, similar to polished, (d) detail of the ground-EDM edge – ductile character, wide cracks and plastic deformation observed around the crack tip.

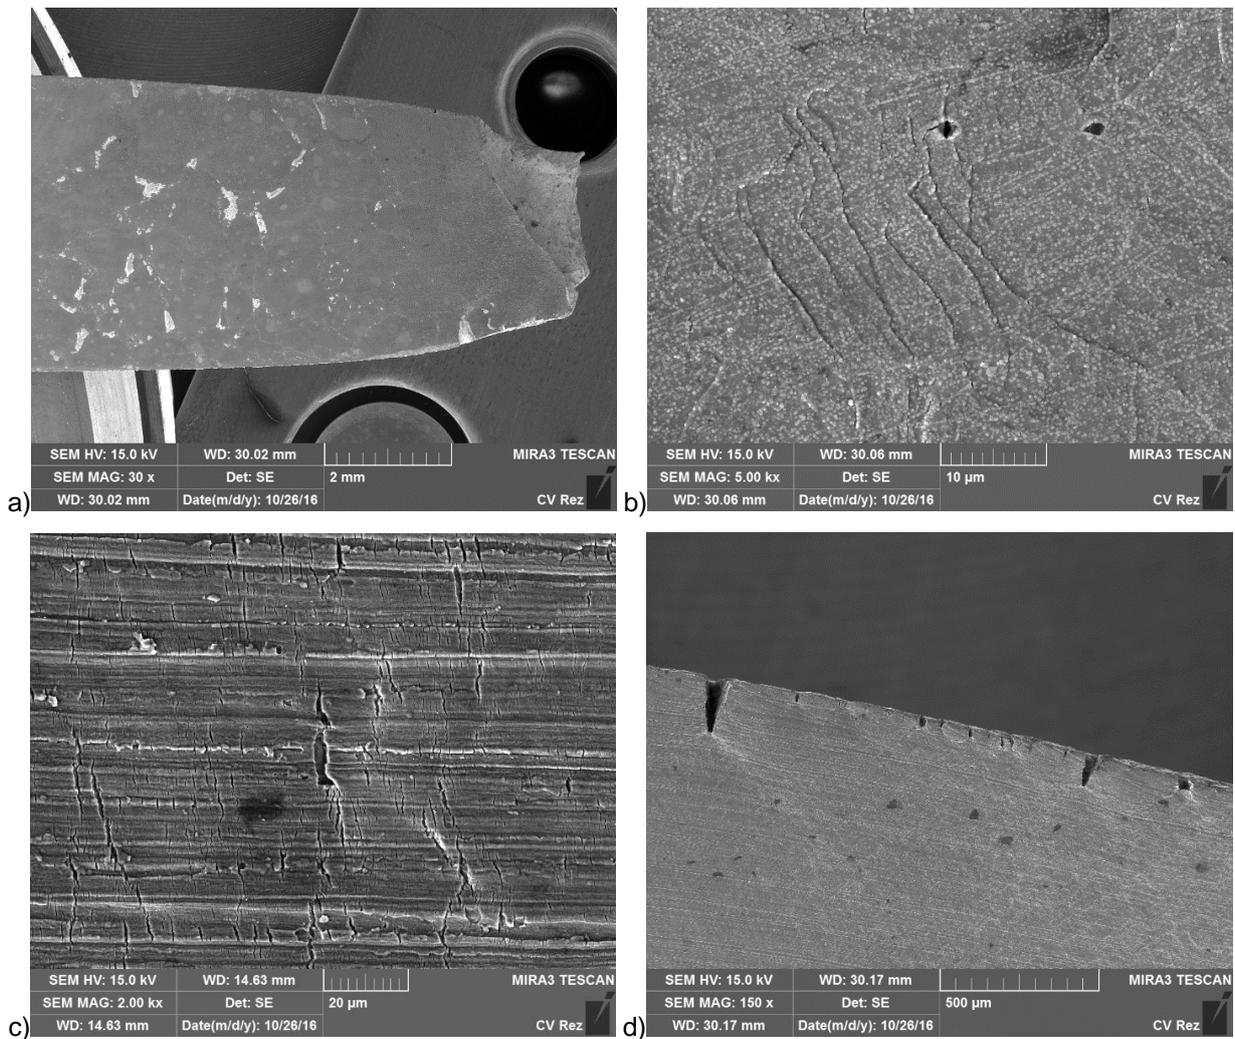
Figure 4.36: (a): T1, rupture (300 °C, LBE, $6 \cdot 10^{-6}$ wt% O), (b) detail, polished side, (c) detail, ground side with cracking, (d) detail, ground-EDM edge – sharp cracking with plastic deformation around the crack tip.

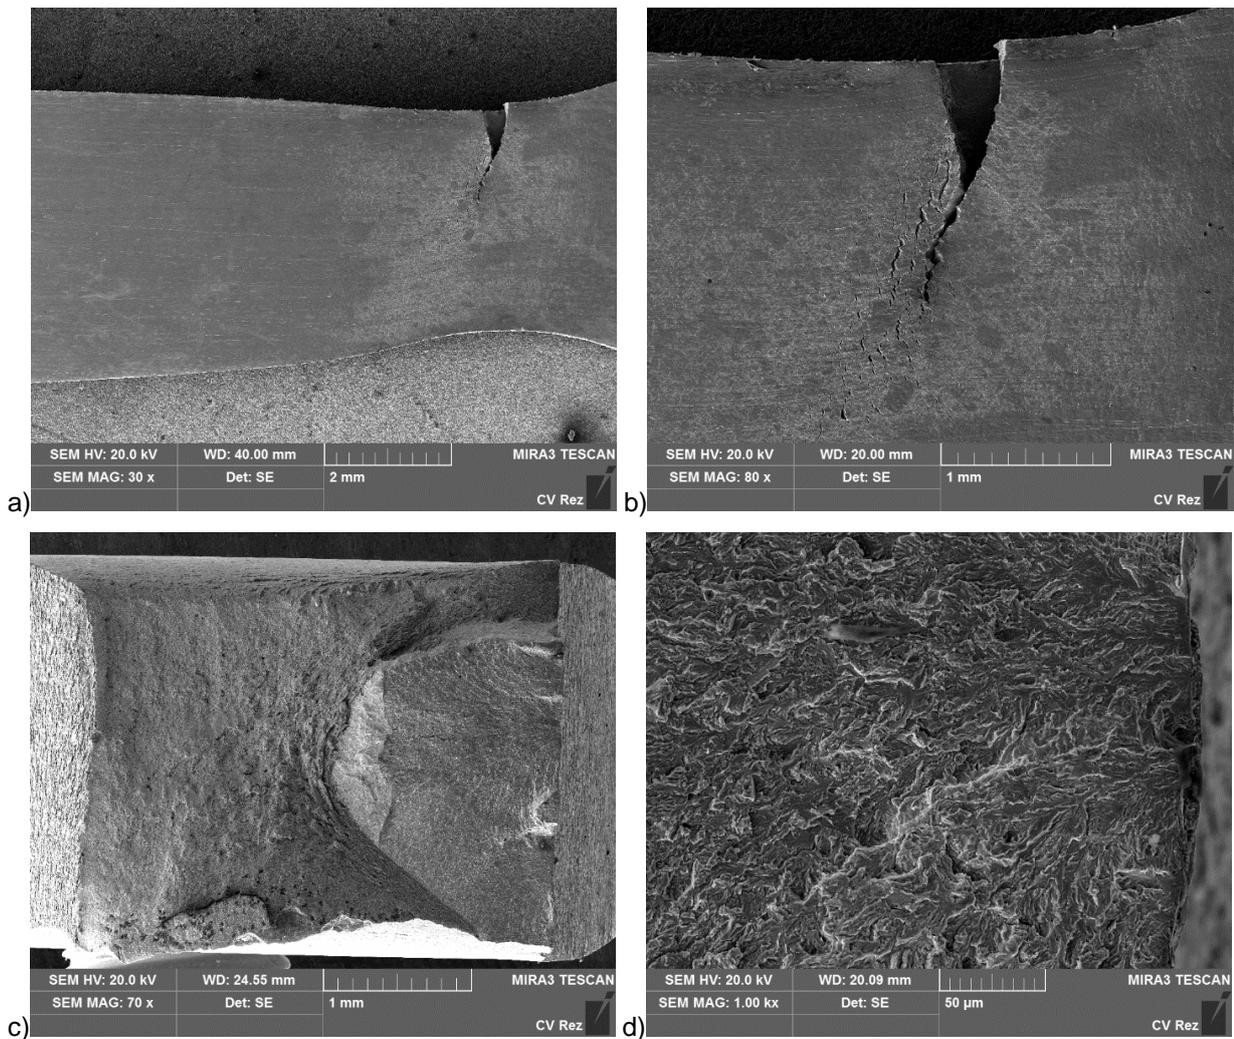
Figure 4.37: (a) T8, rupture (300 °C, LBE, $3 \cdot 10^{-13}$ wt% O), (b) detail on the main crack, ground side, (c) the crack area on the left side of the fracture surface, (d) detail, fracture initiation.

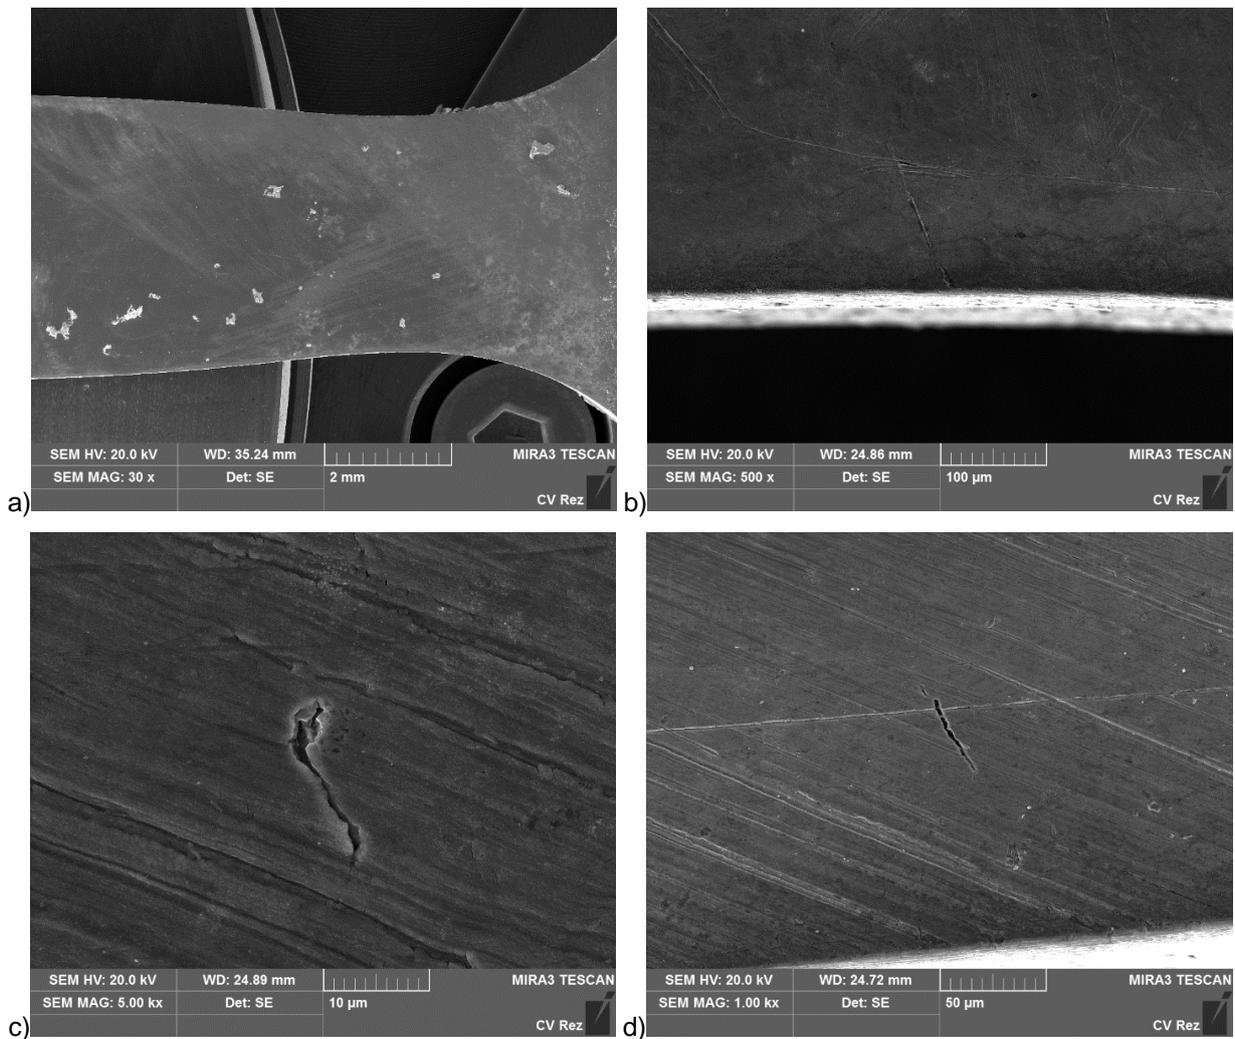
Figure 4.38: (a) T11 (300 °C, LBE, $c_o=3 \cdot 10^{-7}$ wt%) UTS, (b) detail of the edge on the polished side – neck, (c) detail on the crack, ground side – neck, (d) detail, ground side – 2.8 mm from neck.

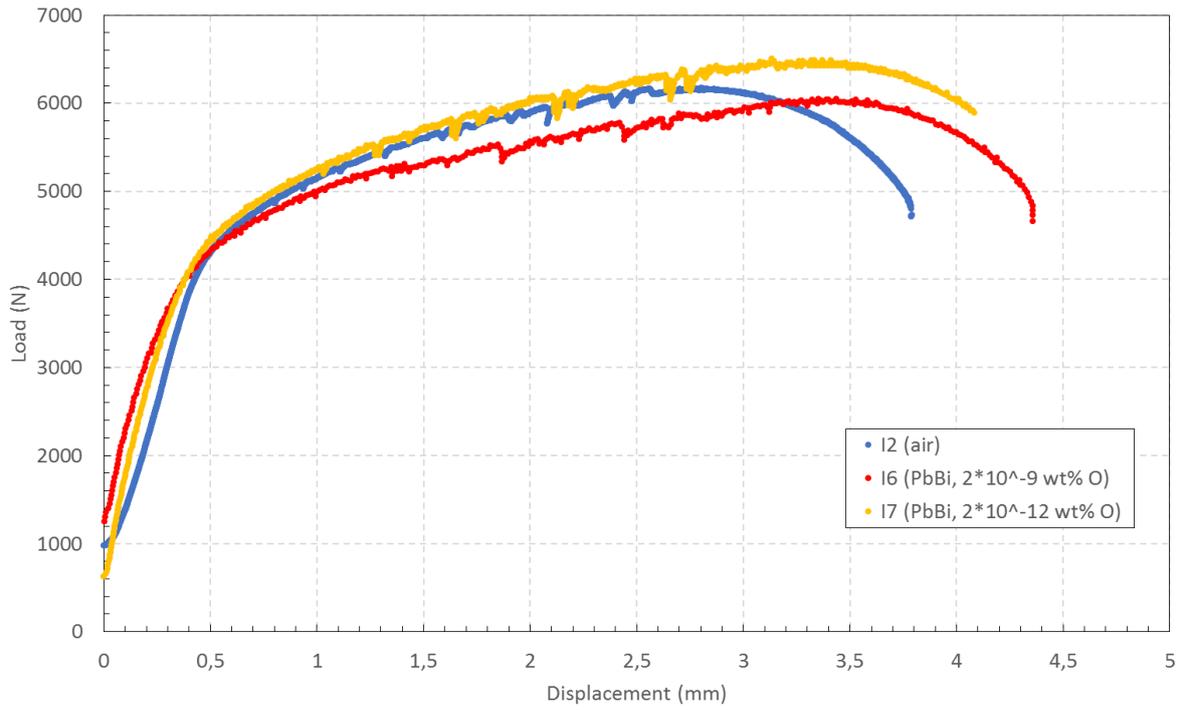
Figure 4.39: Comparison of load-displacement curves of 15-15Ti tapered specimens tested up to rupture at 300 °C.

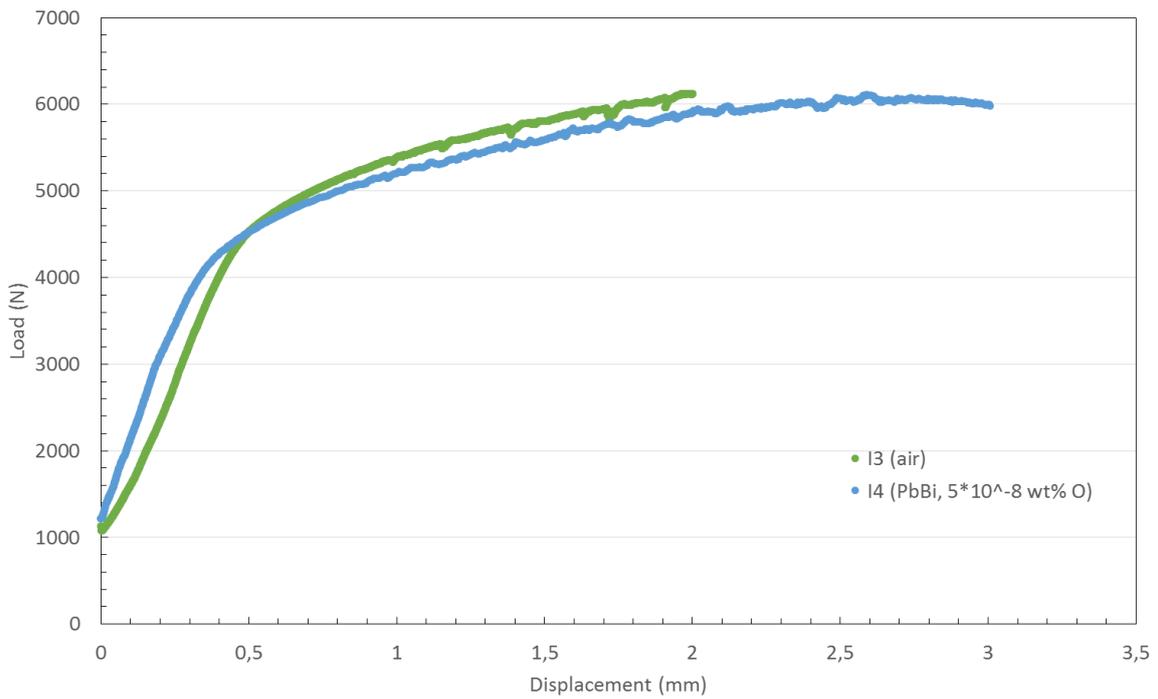
Figure 4.40: Comparison of load-displacement curves of 15-15Ti tapered specimens tested up to UTS at 300 °C.

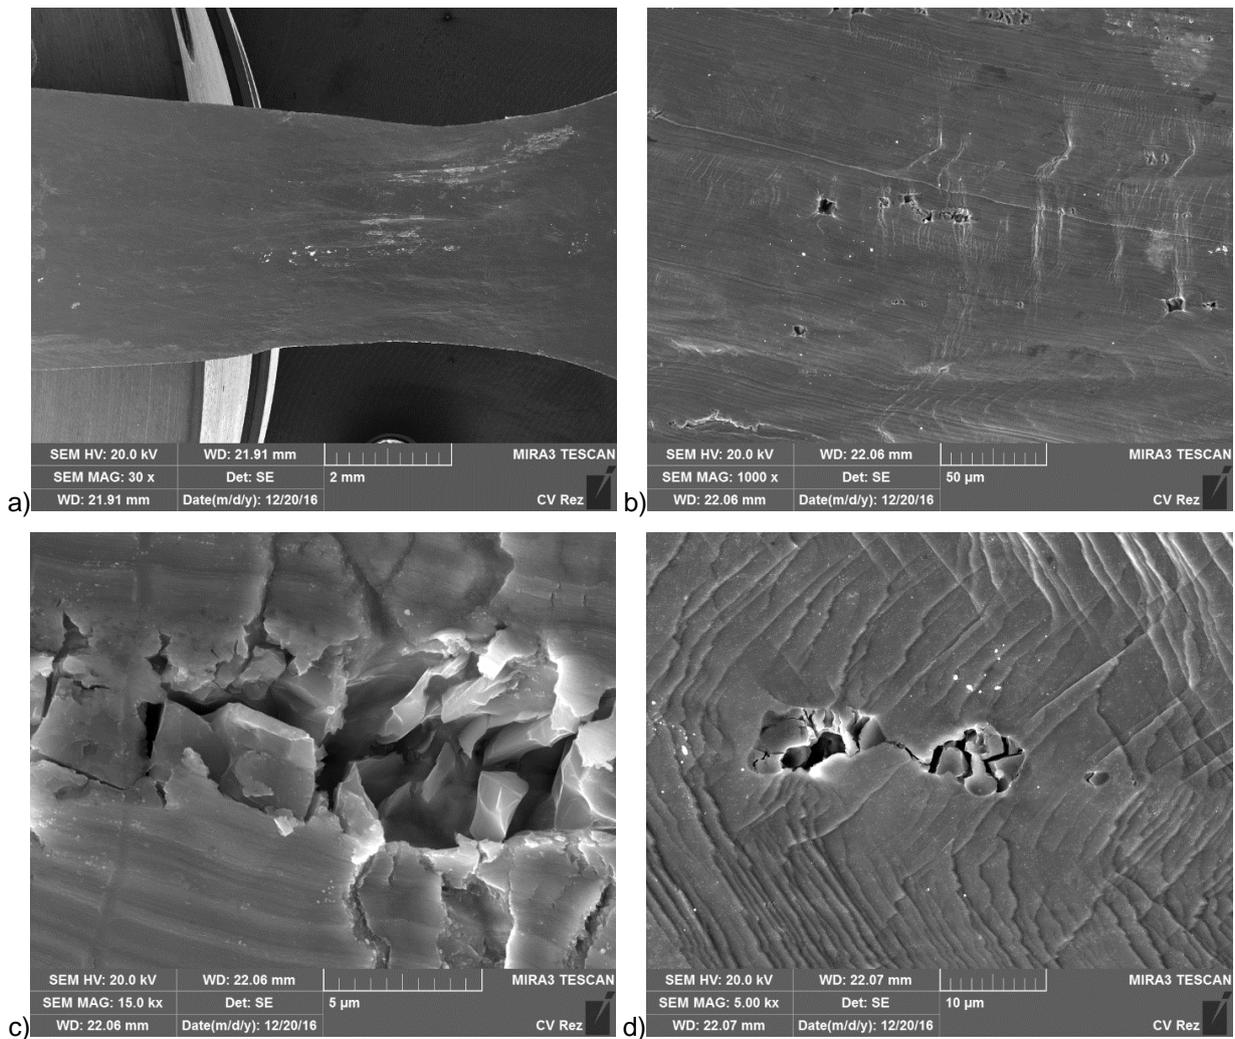
Figure 4.42: (a): I4 (300 °C, LBE, $5 \cdot 10^{-8}$ wt% O), UTS, (b) detail, ground side – neck, (c) detail, ground side – neck, (d) detail, polished side.

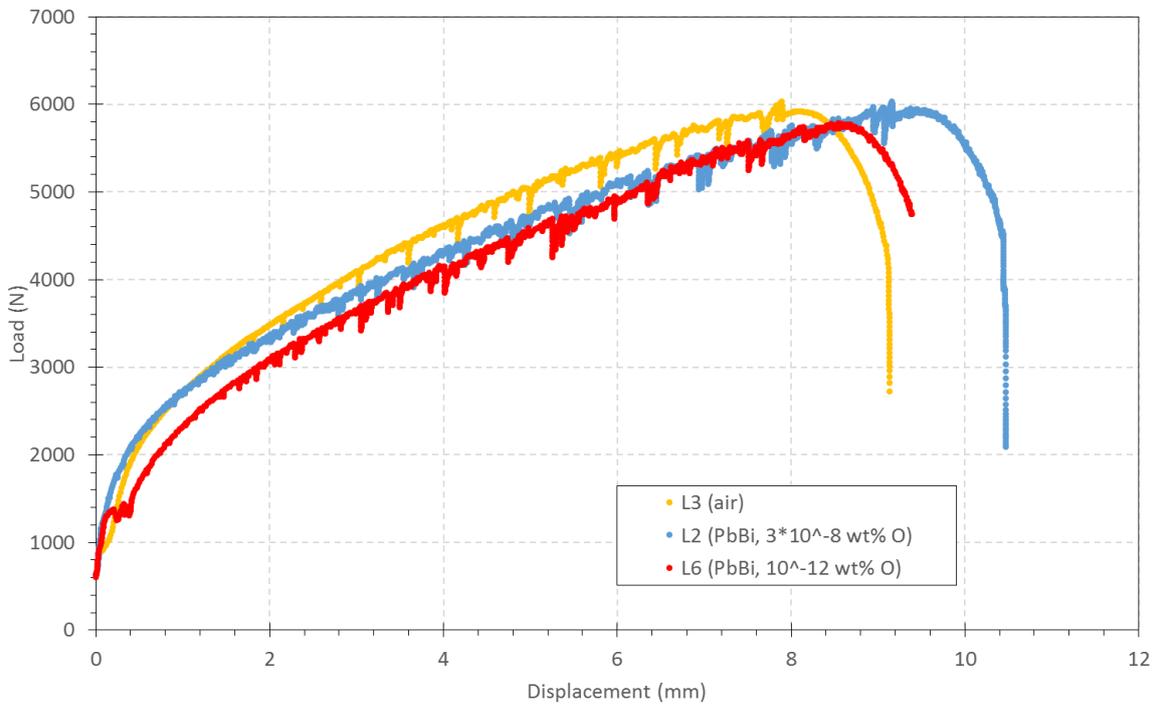
Figure 4.43: Comparison of load-displacement curves of 316L tapered specimens tested up to rupture at 300 °C.

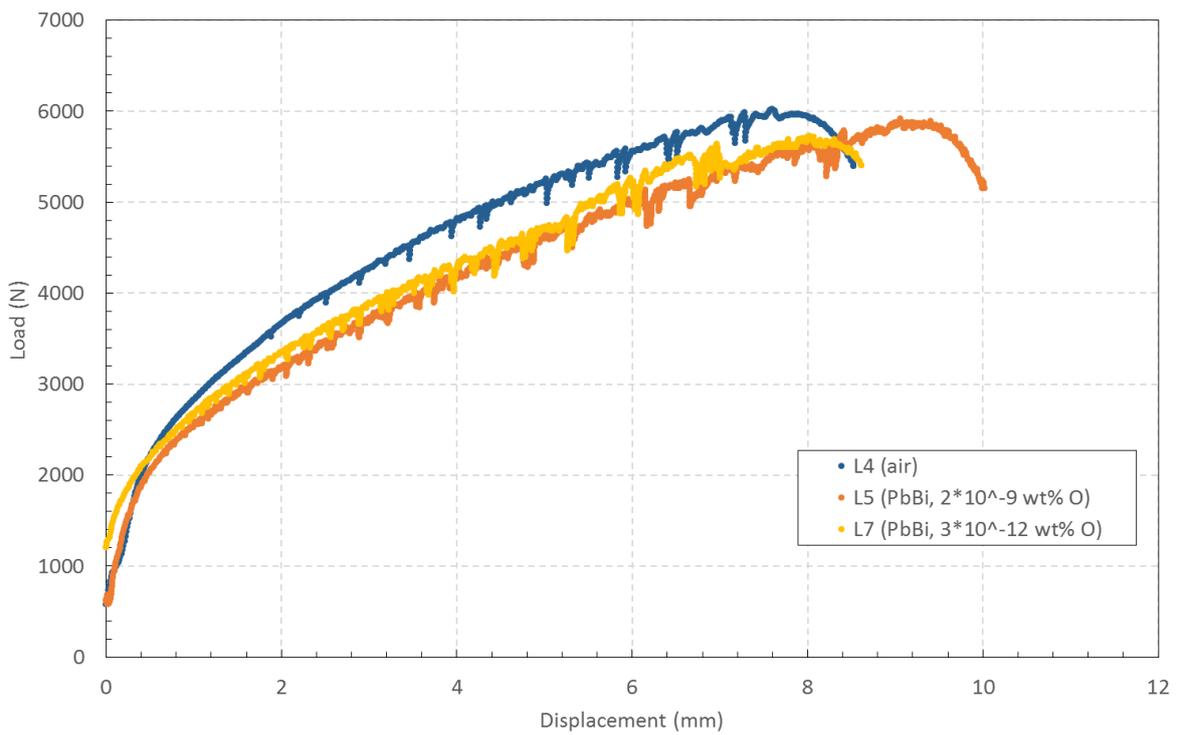
Figure 4.44: Comparison of load-displacement curves of 316L tapered specimens tested up to UTS at 300 °C.

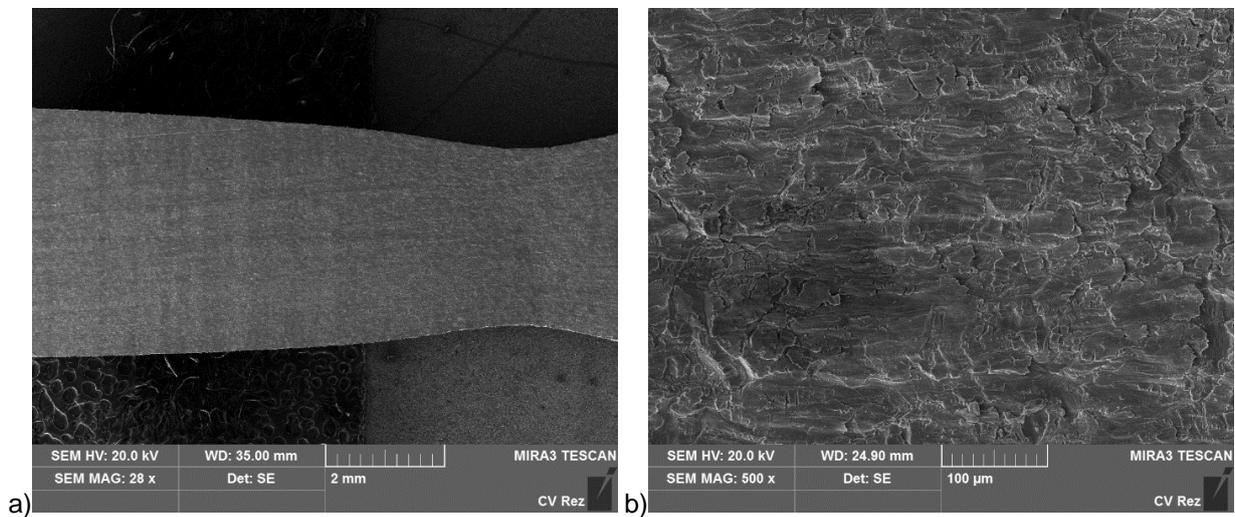
Figure 4.46: (a) L4 (300 °C, air), UTS, (b) detail on the necking, ground side.

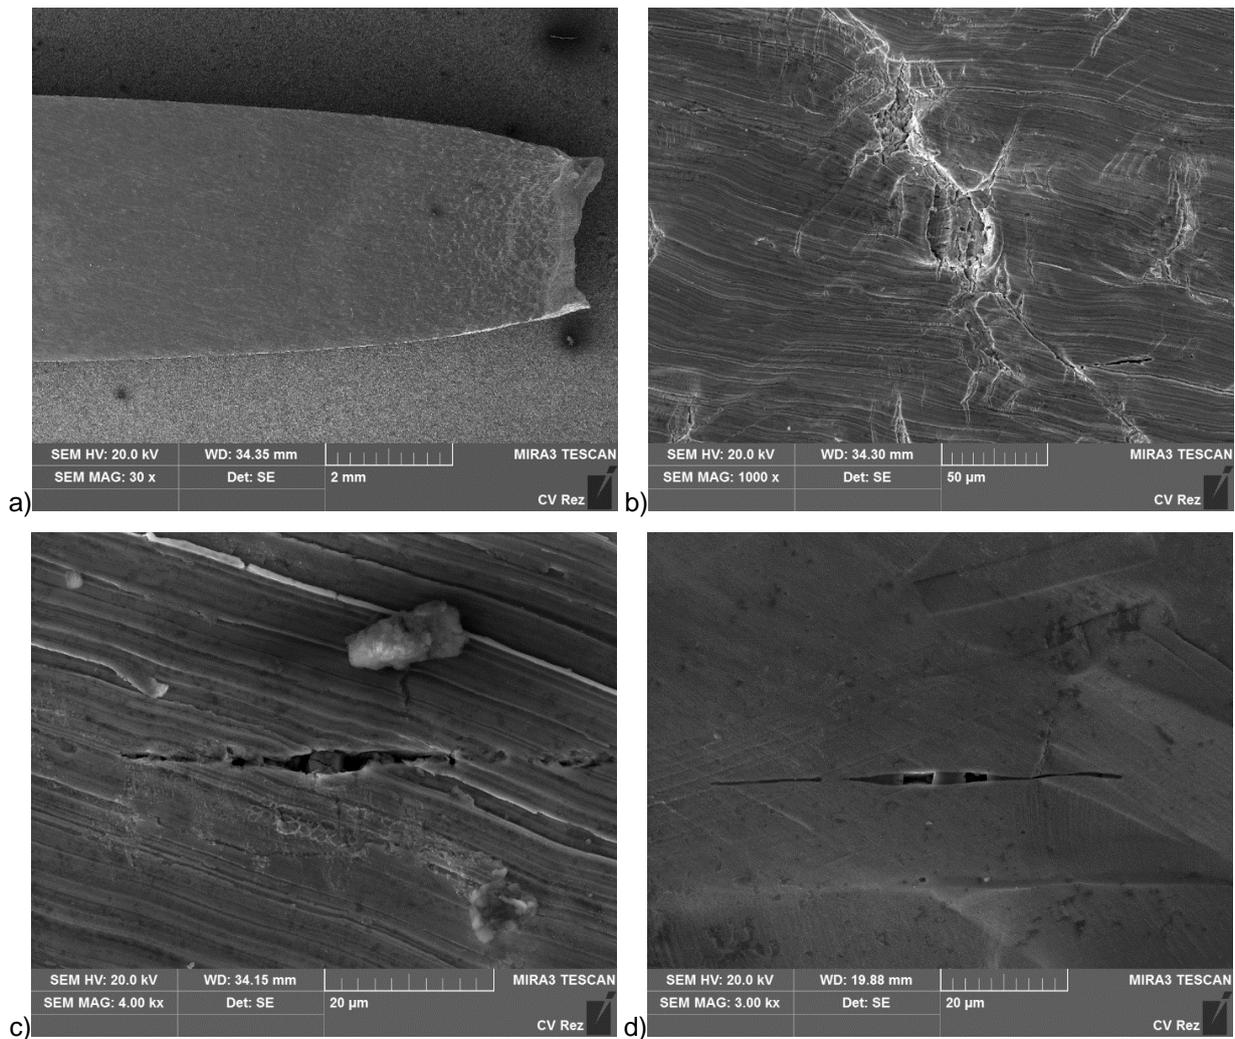
Figure 4.47: (a) L2 (300 °C, LBE, $3 \cdot 10^{-8}$ wt% O), (b) detail, ground side – 1.4 mm from the rupture (necking), (c) detail, ground side – 10.5 mm from the rupture, (d) detail, polished side.

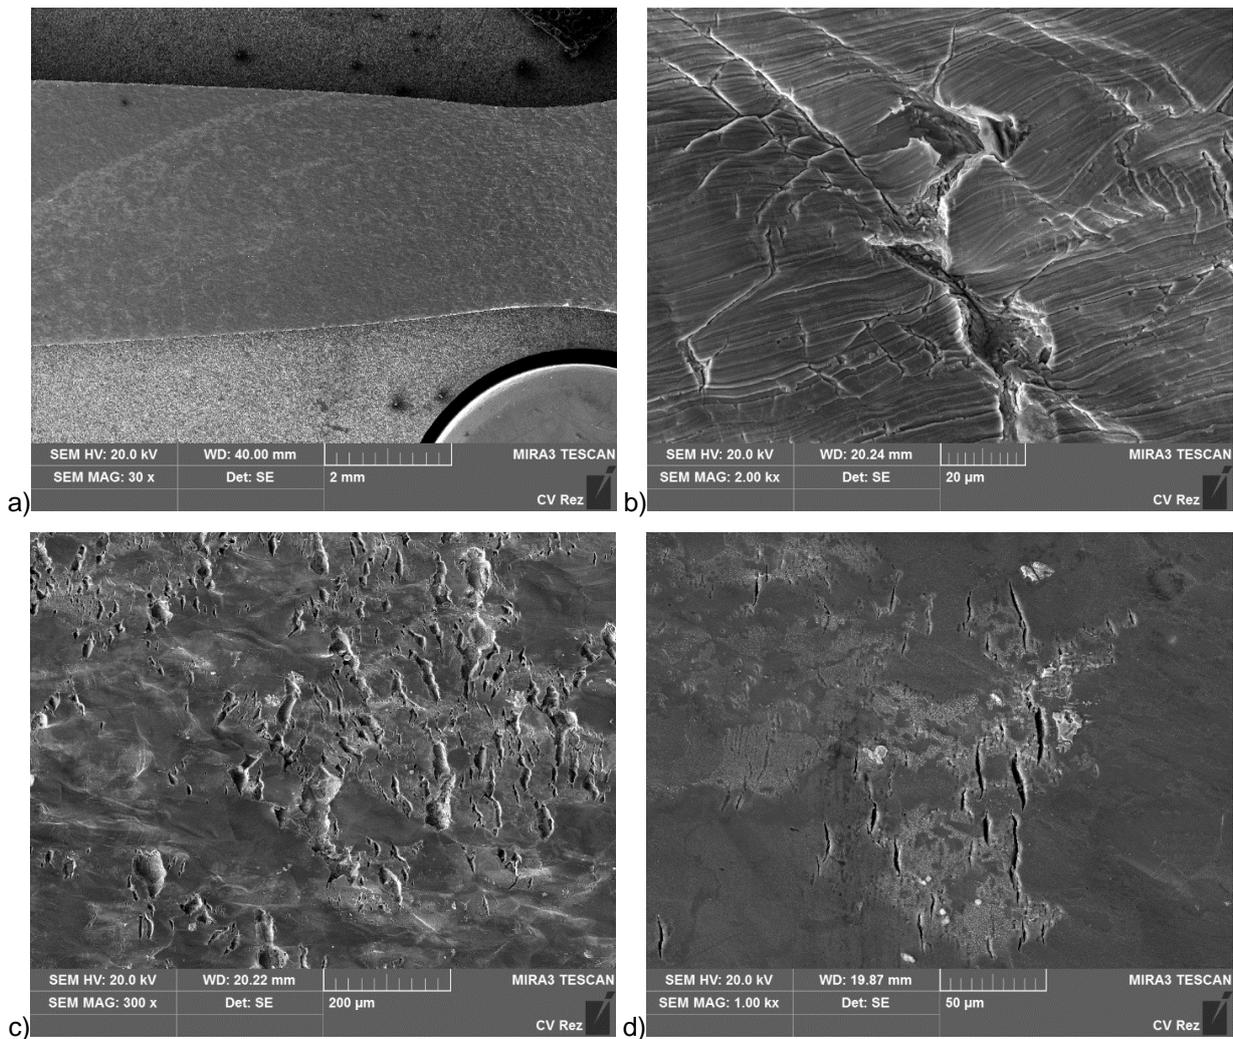
Figure 4.48: (a) L7 (300 °C, LBE, $3 \cdot 10^{-12}$ wt% O), UTS, (b) detail, ground side – neck, (c) detail polished side – neck, (d) detail, polished side – in the maximum distance.

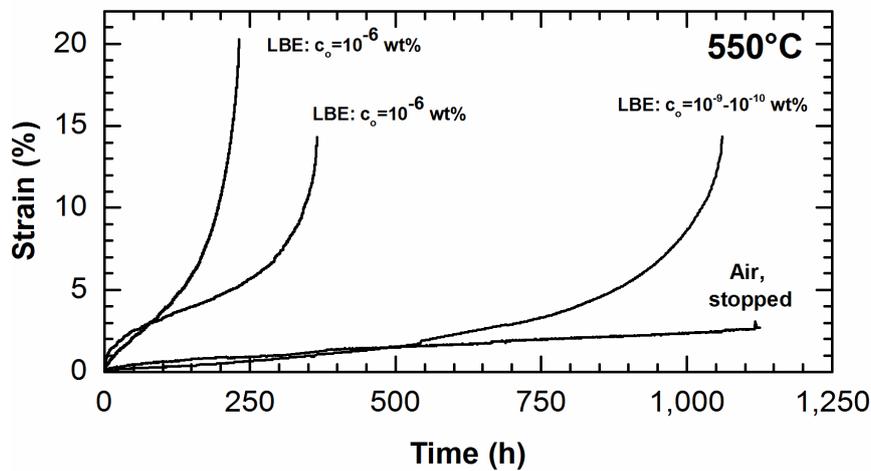
Figure 4.50: Strain-vs.-time curves obtained with 316L during creep(-to-rupture) testing in LBE with lowering oxygen content as well as $c_o = 10^{-6}$ wt% and air at 550 °C.

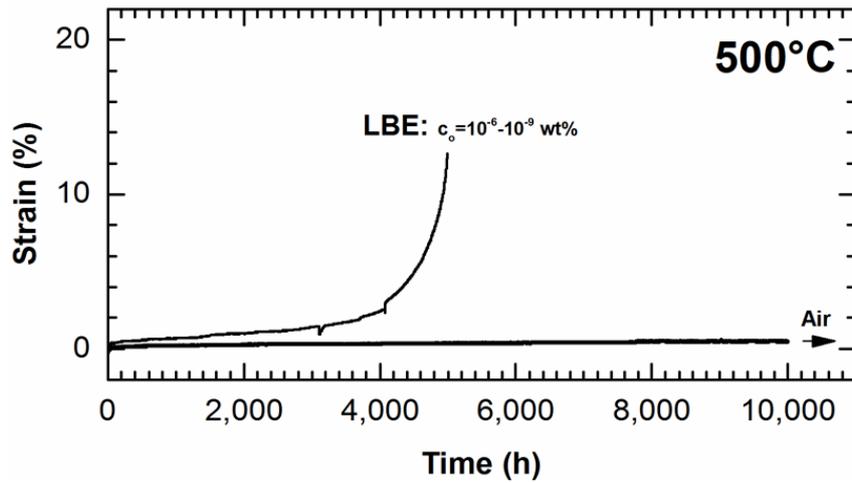
Figure 4.51: Strain-vs.-time curves obtained with 316L during creep(-to-rupture) testing in LBE with lowering oxygen content and air at 500 °C.

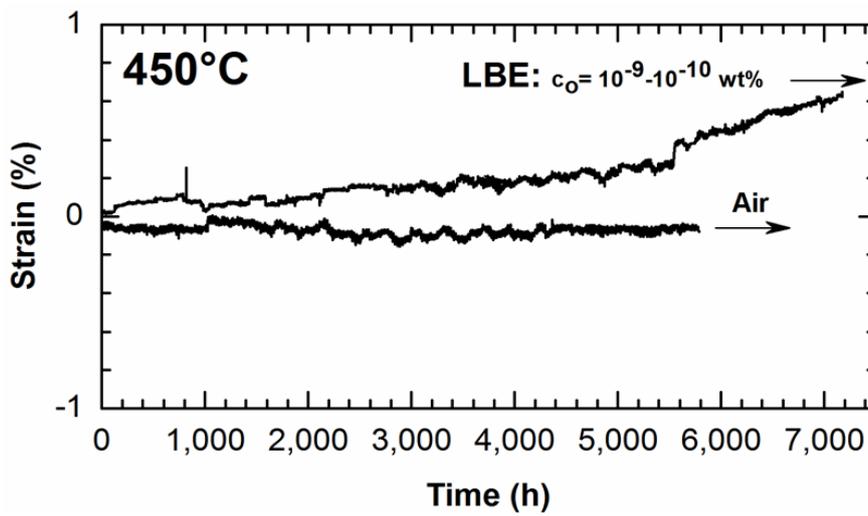
Figure 4.52: Strain-vs.-time curves obtained with 316L during creep(-to-rupture) testing in LBE with lowering oxygen content and air at 450 °C.
