**Support to the development of joint research actions
between national programmes on advanced nuclear materials**

FP7-Fission-2013
Combination of Collaborative project (CP) and Coordination and Support Actions (CSA)

D.5.42

***Report for mech./microstr. character. of environ.
assisted degrade. effects of steels in lead alloys
and assess. of environm. degrad. effects on perf.
of struct. and funct. comp. of MYRRHA ADS &
LFR***

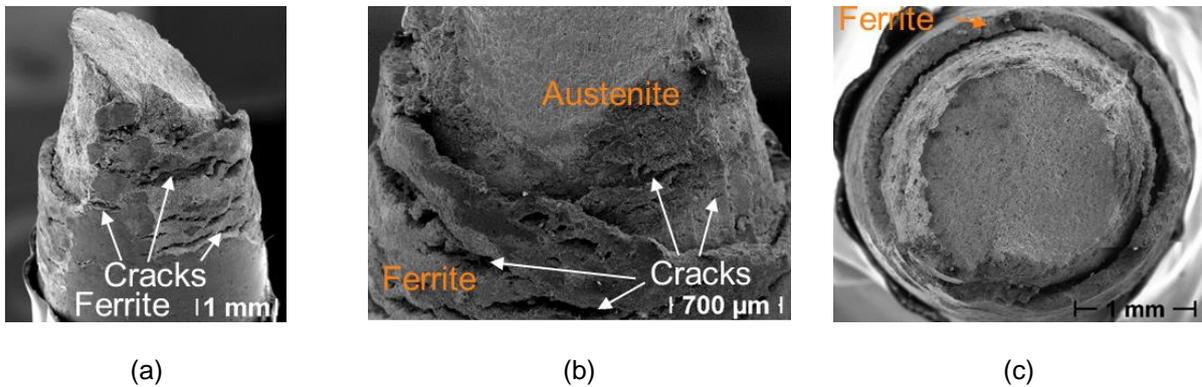
Figure 4.53: Failure of the austenitic steel 316L tested in LBE at 550°C and $c_o=10^{-7}$ - 10^{-10} wt% for 1,060 h: (a) and (b) side view, (c) top view of the failure.

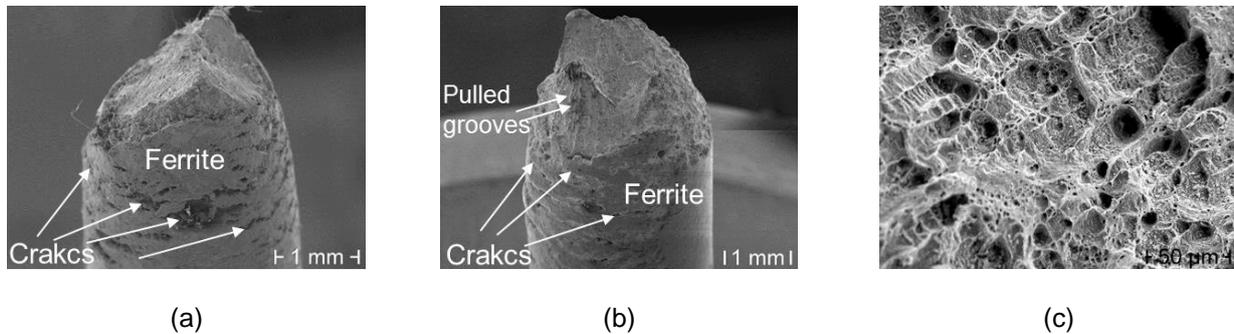
Figure 4.54: Failure of the austenitic steel 316L tested in LBE at: (a) 550°C and $c_o = 10^{-6}$ wt% for 182 h; (b) 500°C and $c_o = 10^{-8}$ - 10^{-9} wt% for 5,025 h; (c) typical for ductile fracture dimples characterized failure surfaces of the ruptured 316L in LBE at 500 and 550°C.

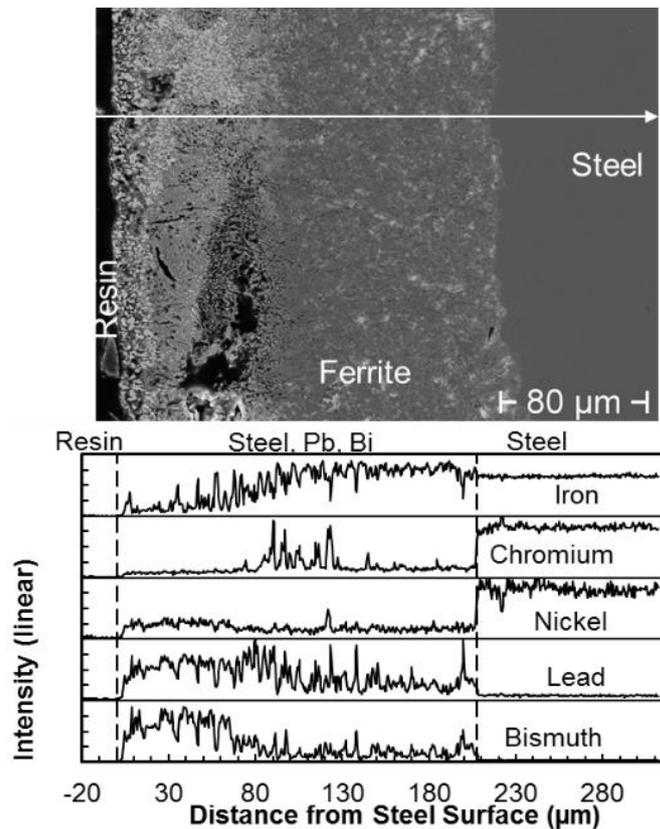
Figure 4.56: Elemental profile of ferrite layer formed on the surface of the austenitic steel 316L in static LBE at 550°C and $c_o=10^{-7} - 10^{-10}$ wt% during 1.060 h .

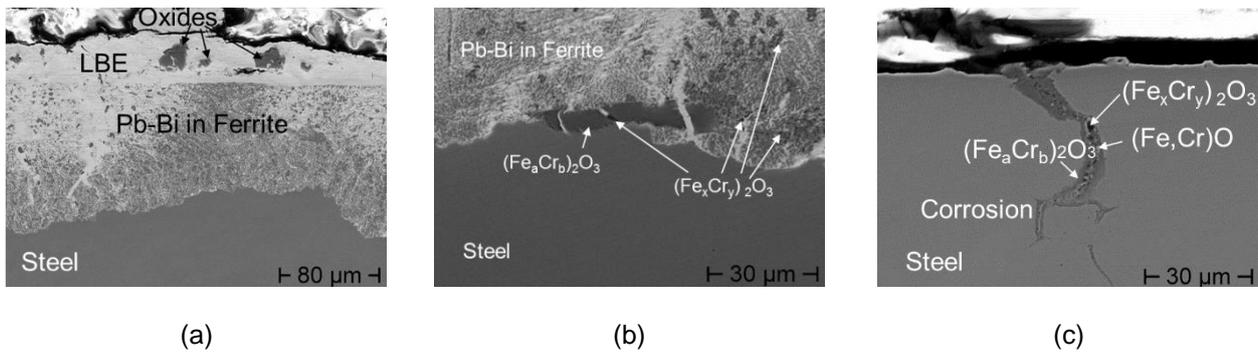
Figure 4.57: Perpendicular cross-section of 316L ruptured in LBE ($c_o=10^{-6}$ wt%) at 550°C after 365 h. The specimen is not cleaned from the rest of LBE from the surface after creep-to-rupture test.

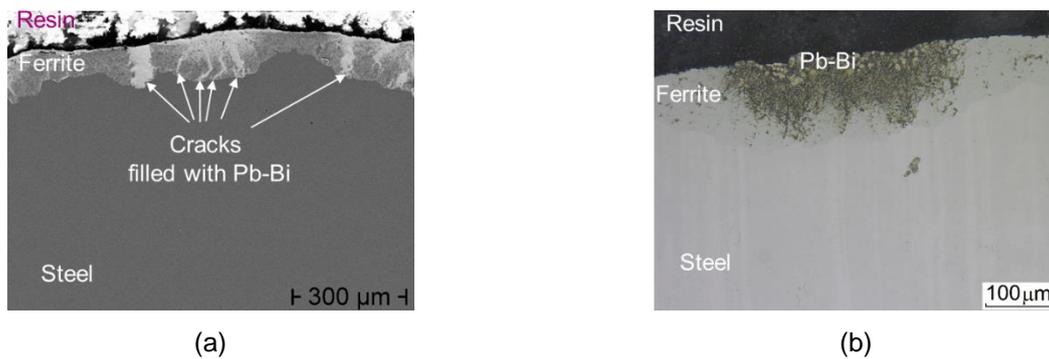
Figure 4.58: Comparison of (longitudinal) cross-section of 316L crept in stagnant LBE ($c_o=10^{-6}$ wt%) at 550°C after 231 h (a) and 316L exposed to flowing LBE (~ 2 m/s, $\sim 10^{-7}$ wt%) for 2,011 h at 550°C [49] (b).

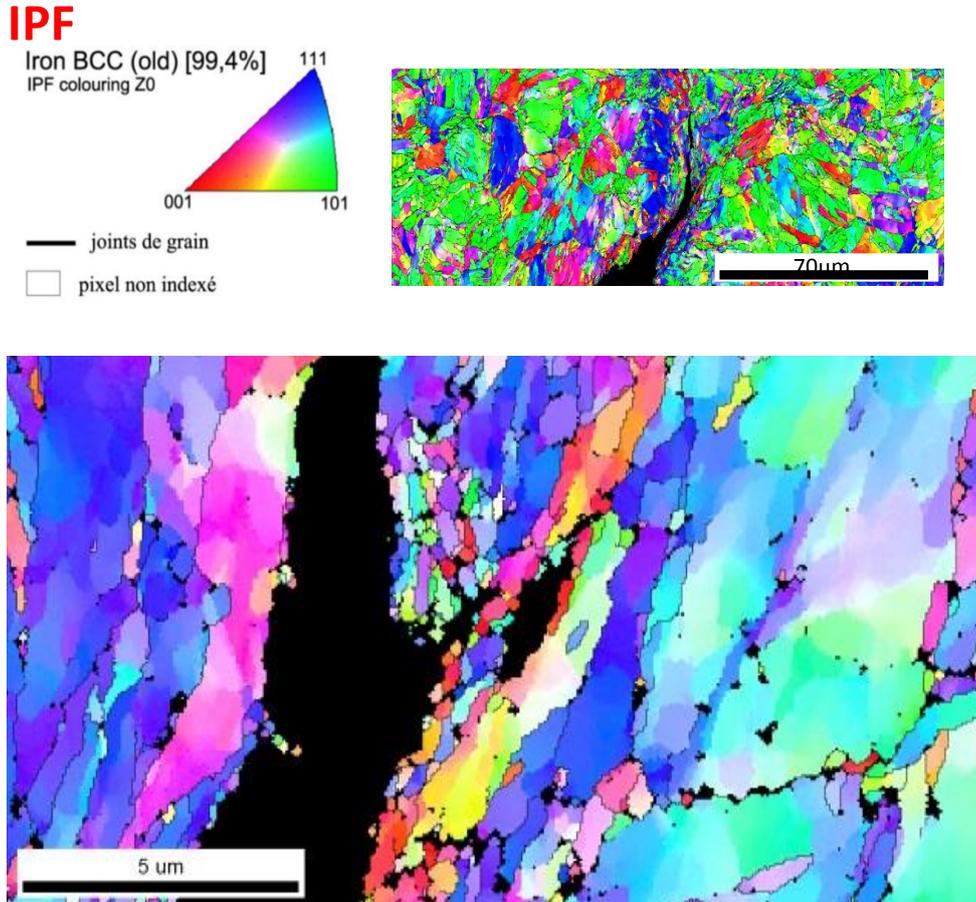
Figure 4.59: EBSD map of crack tip advance in T91 (fatigue test, air, 350 °C).

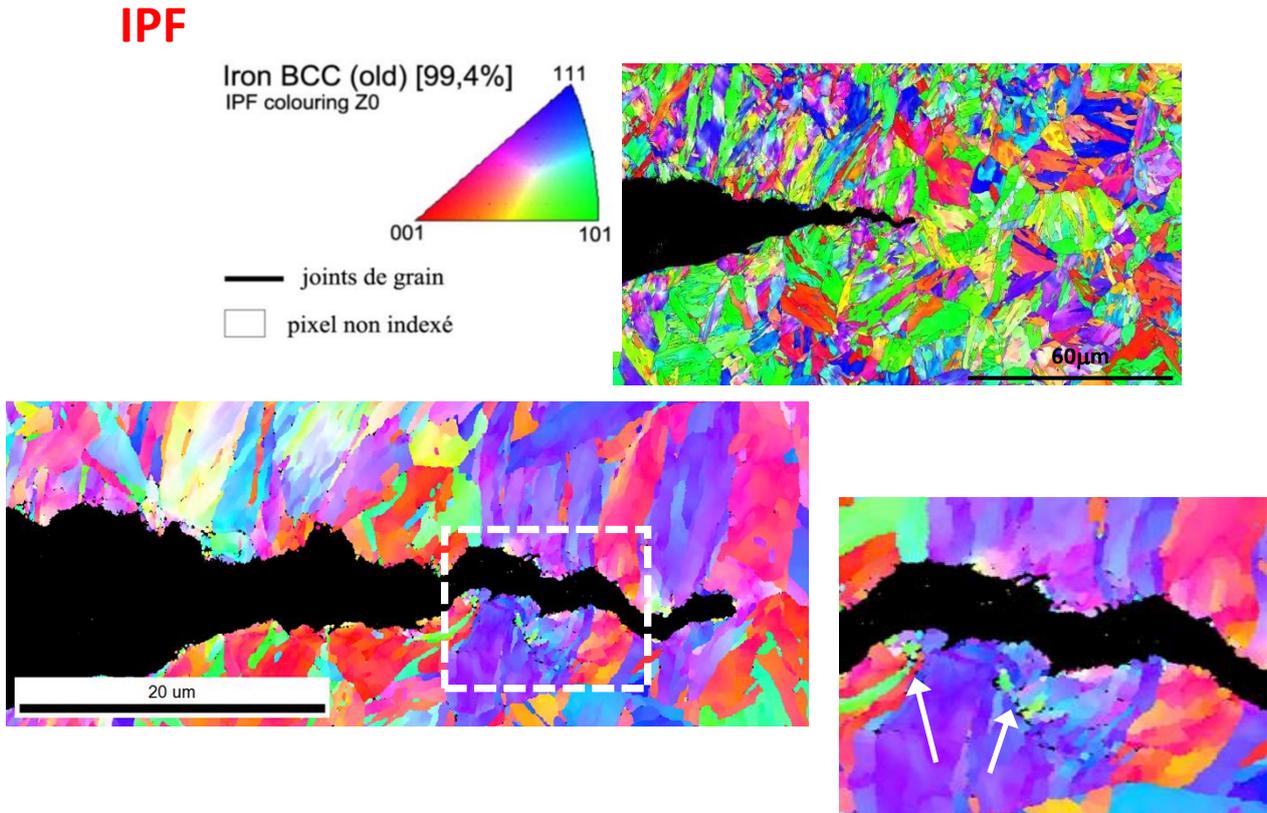
Figure 4.60: EBSD map of crack tip advance in T91 (fatigue test, LBE, 350 °C).

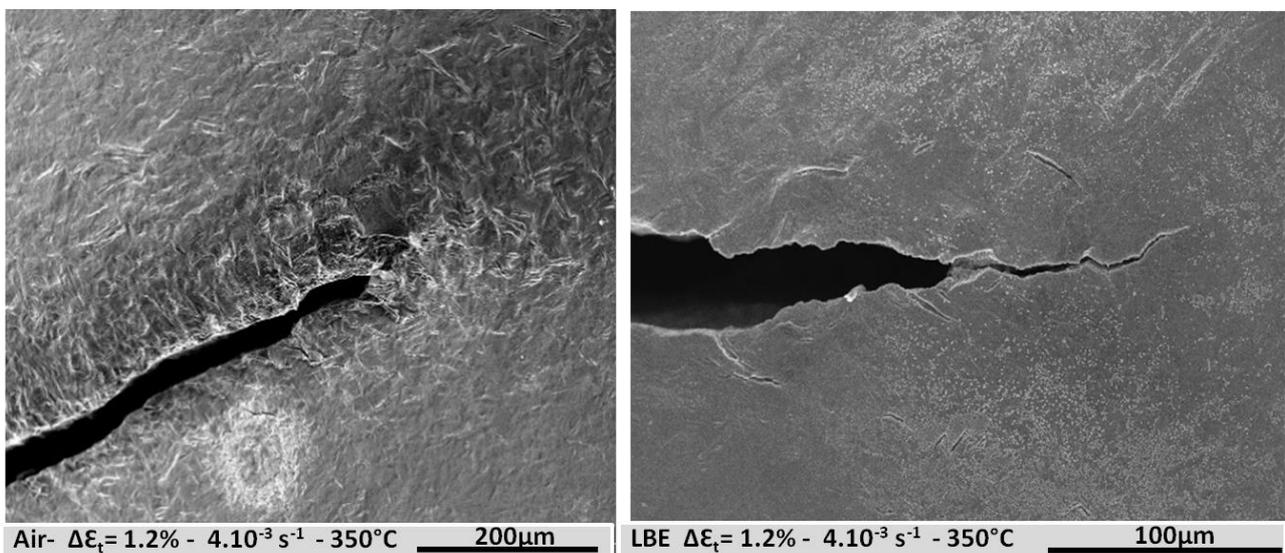
Figure 4.61: Comparing of crack tip shape – air vs LBE (T91, fatigue test, 350 °C).

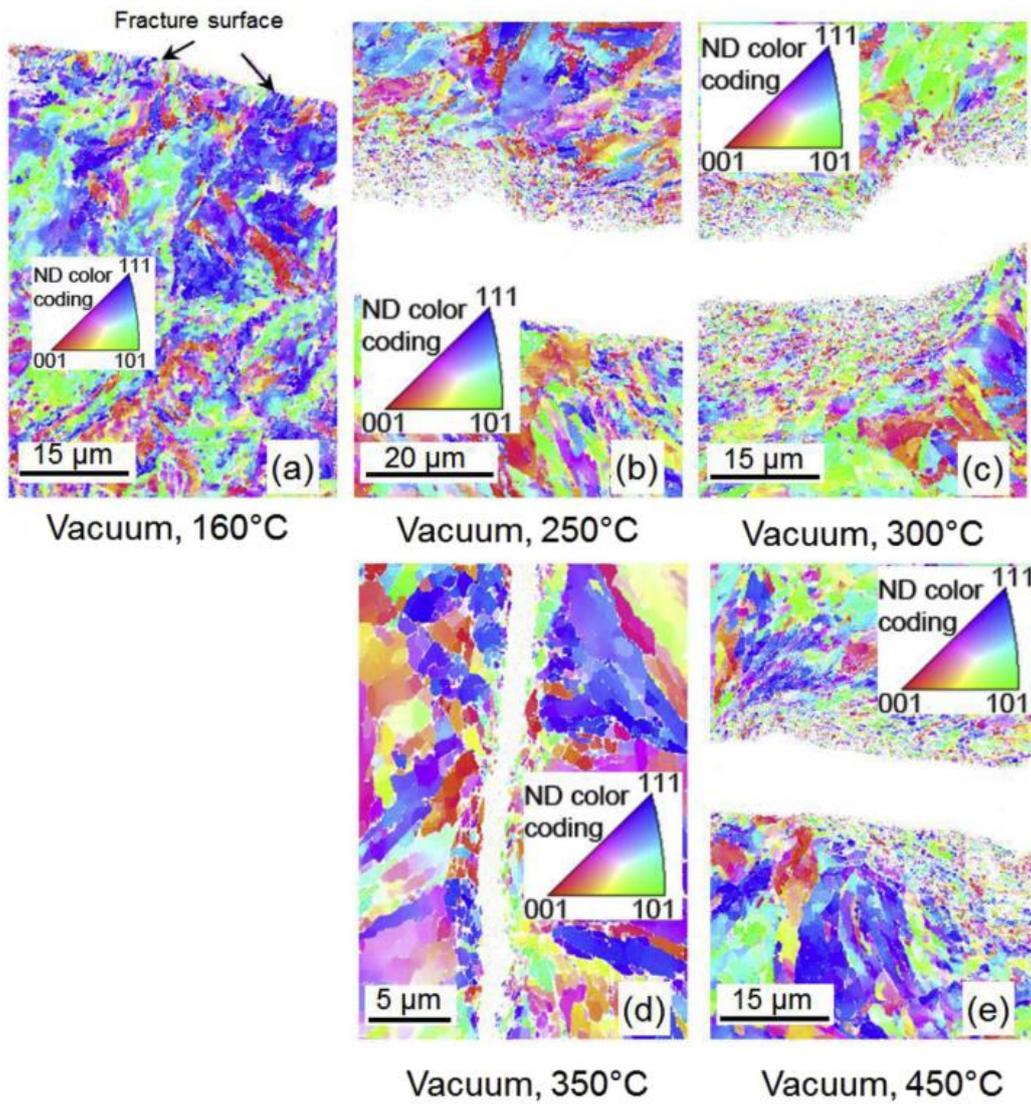
Figure 4.62: EBSD orientation maps showing the vicinity of fatigue cracks tested at different temperatures in vacuum [44].

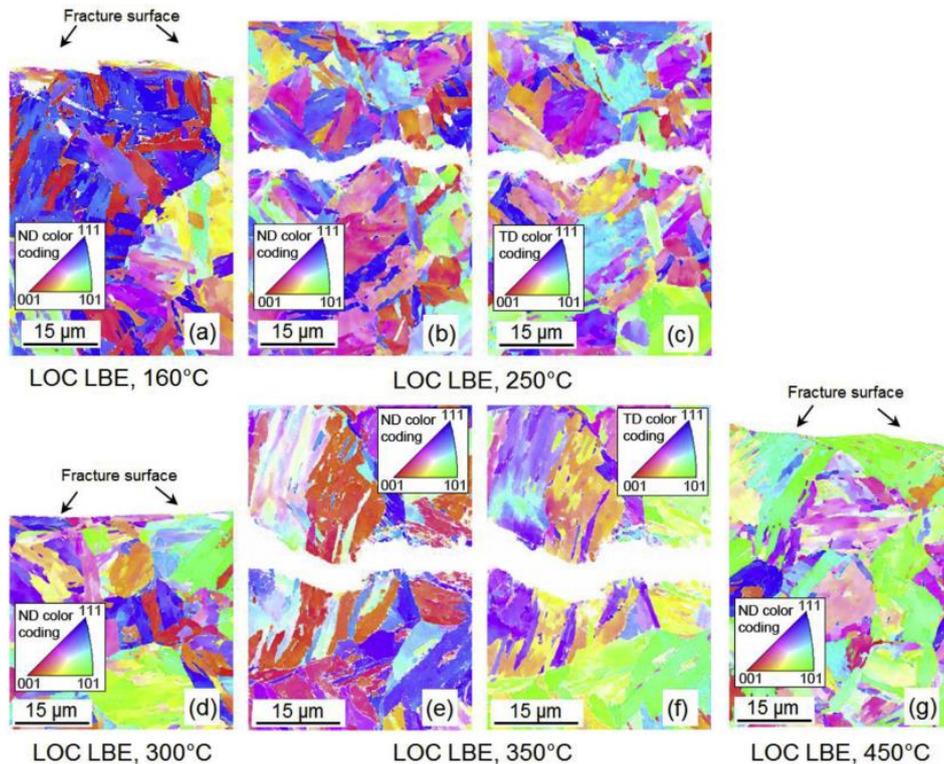
Figure 4.63: EBSD orientation maps showing the fatigue crack vicinity of samples tested at different temperatures in LBE [44]

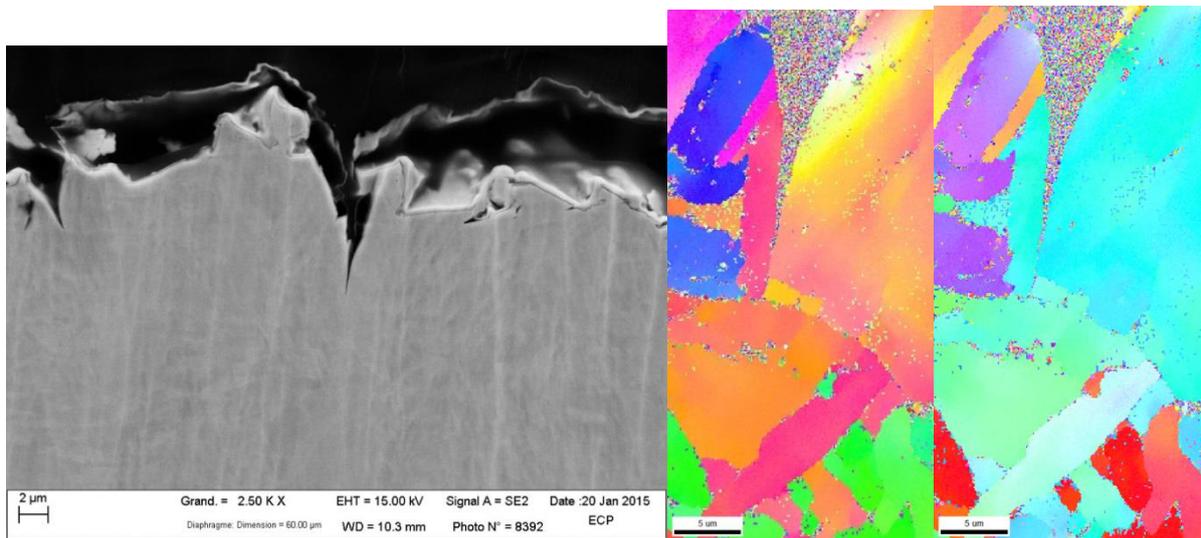
Figure 4.64: a) SEM view of the liquid nitrogen cracked area from Sample 1 b) EBSD mapping

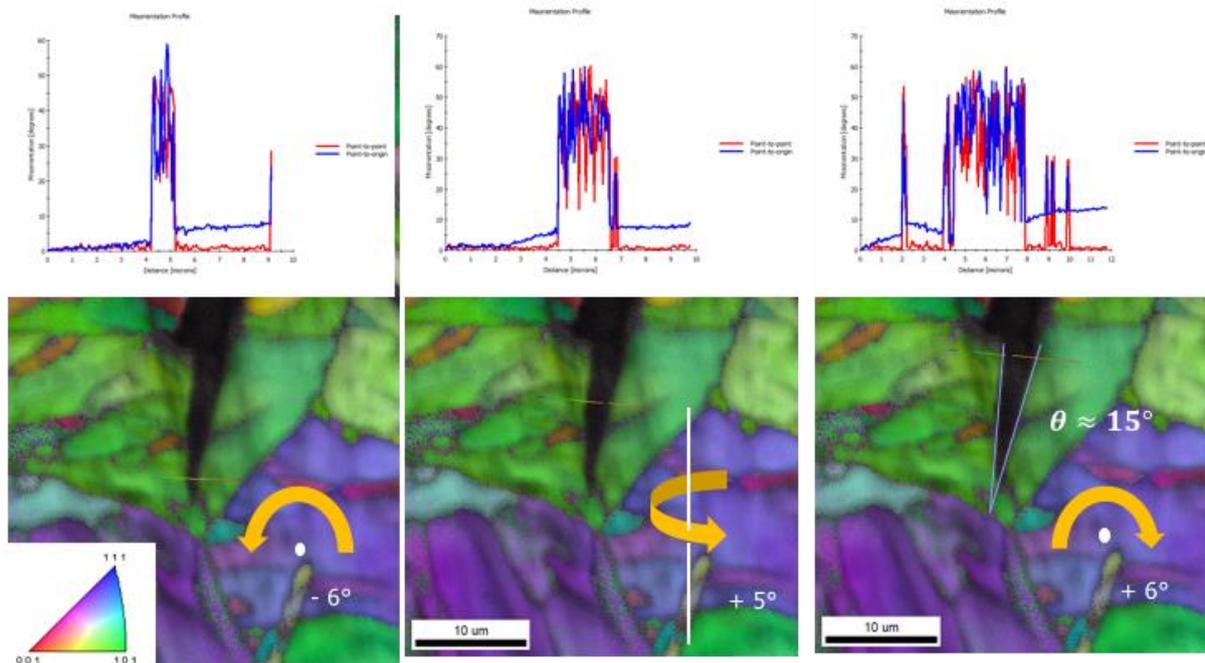
Figure 4.66: Orientation mapping by EBSD of the area, line profiles and rotations on the lips of the crack: a) near the crack tip b) in the middle part of the crack above the previous one c) away from the crack tip.

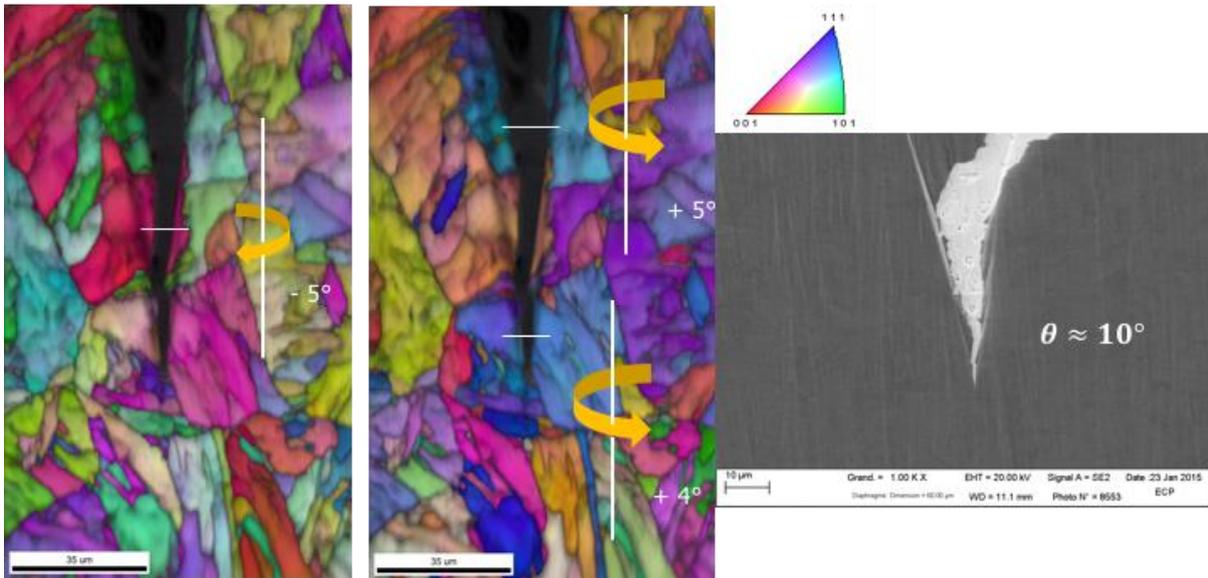
Figure 4.68: a) IPF view+axis of rotation on the lips of the profile b) IPF view of 90° rotated +axis of rotation on the lips of the profile c) SEM view of the area from Sample 3 selected for EBSD mapping.

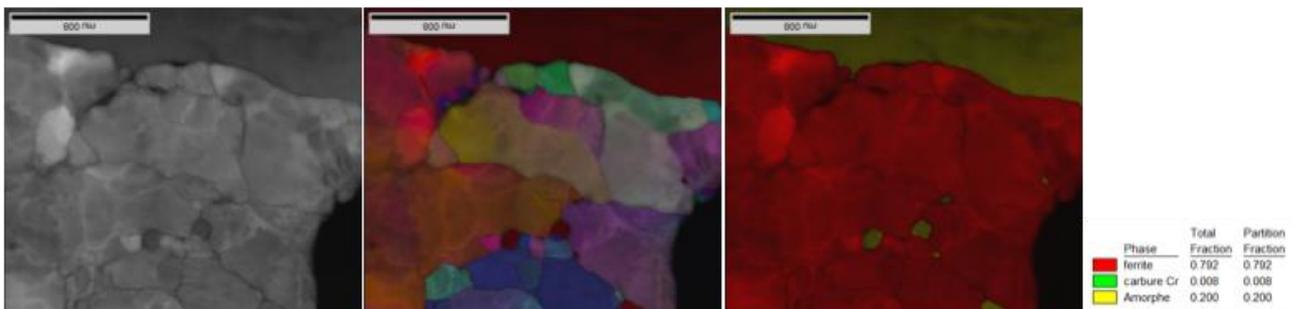
Figure 4.68: a) TEM view of the area from Sample 4 selected via FIB sampling b) high resolution orientation mapping c) phase map of the corresponding area

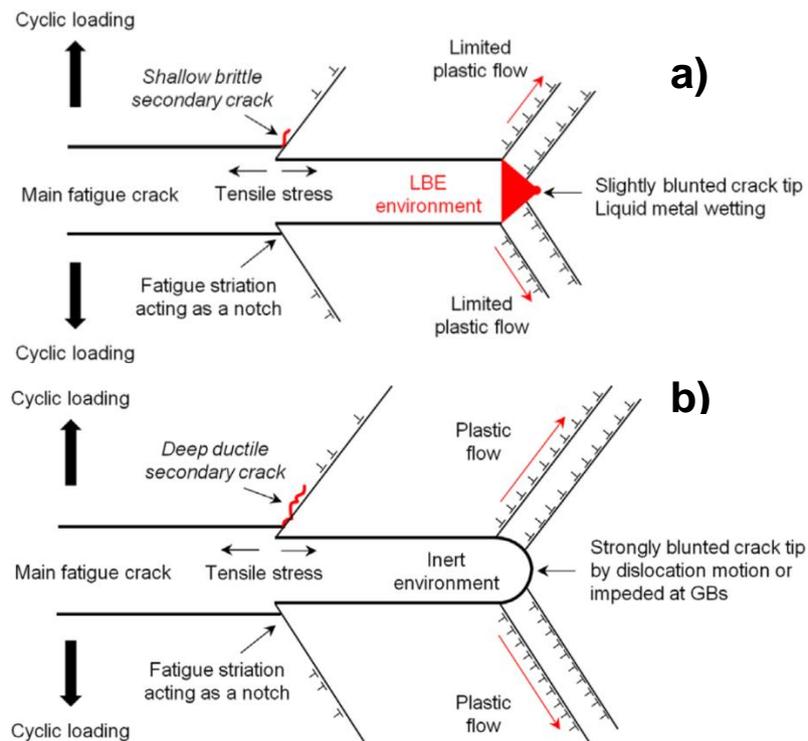
Figure 5.1: Outline of the formation mechanism of secondary cracks in a) LBE environment and b) inert environment [33].

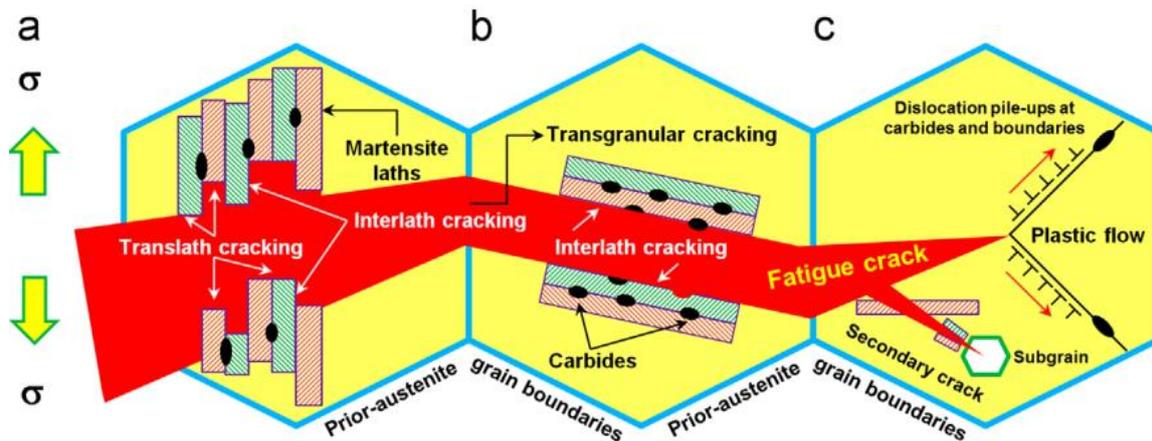
Figure 5.2: Illustration of different crack propagation modes [33].
